Construction Analysis

Intel Pentium Processor W/MMX

Report Number: SCA 9706-540

INTEGRATED CIRCUIT ENGINEERING

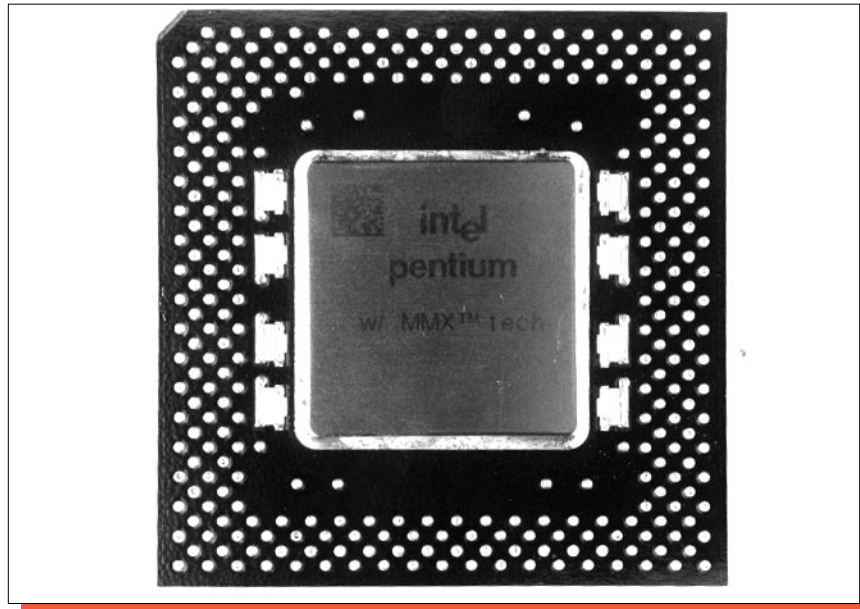
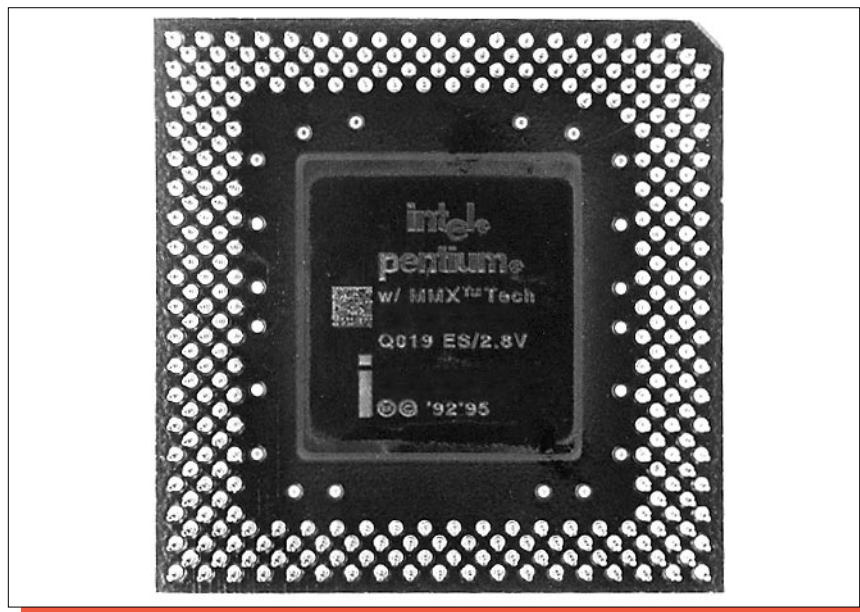
Figure 1. Package photographs of the Intel Pentium with MMX. Mag. 1.5x.

- The device was packaged in a 296-pin SPGA. A metal heatsink was employed on top of the package. The die was mounted cavity down. The PGA was constructed of fiberglass and was coated with a black epoxy-like material. The cavity was filled-in with black plastic material.

- Overall package quality: Good. No defects were found on the external or internal portions of the packages. External pins were straight and placement was good. No voids were noted in the plastic cavity fill.

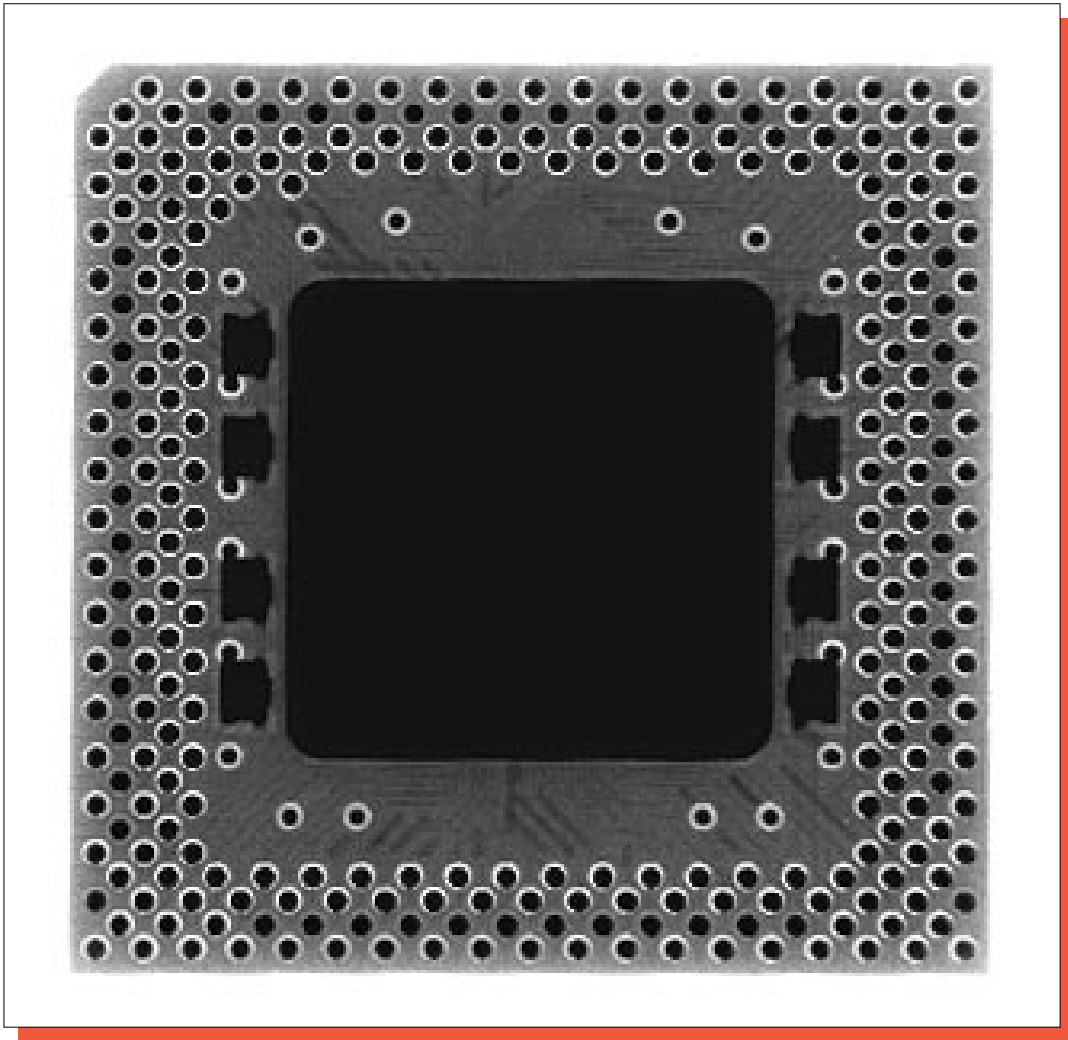
Figure 2. Topological x-ray view of the package. Mag. 2.5x.

- Wirebonding: Ultrasonic wedge bond method using gold wire. A three tier package land structure was used. Wire spacing and placement was good. Bond pitch was very close (95 microns); however, no problems were noted.

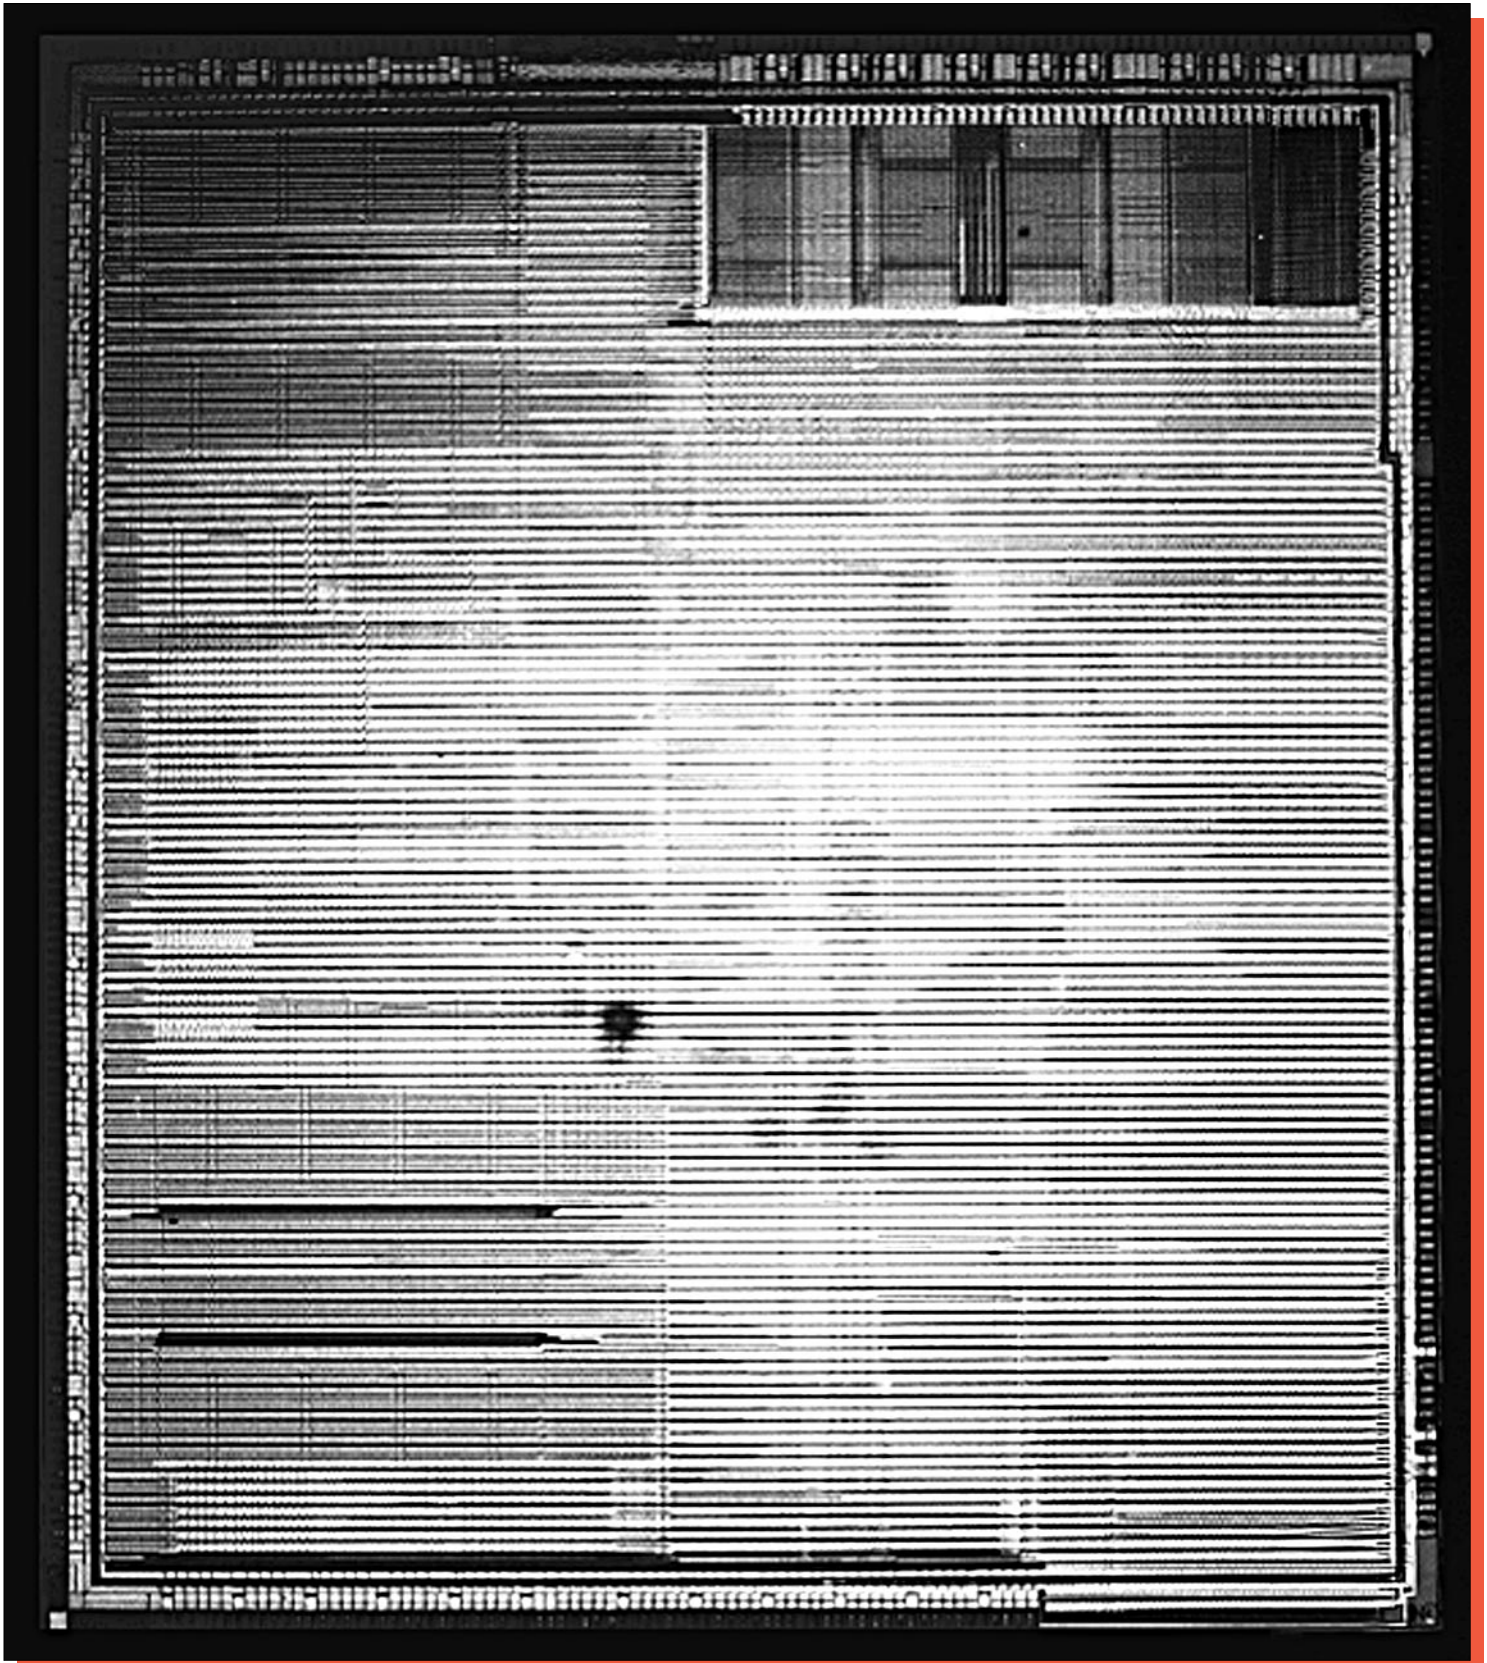
Figure 3. Whole die photograph of the Intel Pentium with MMX. Mag. 16x.

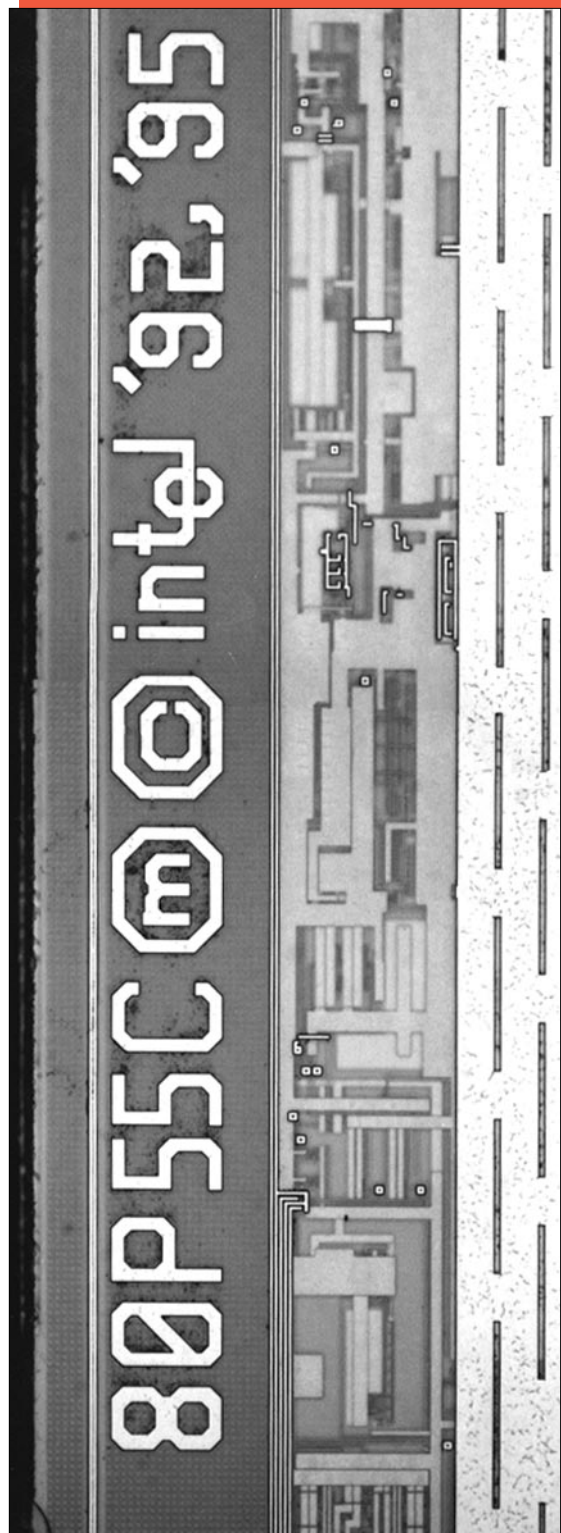
Figure 4. Die identification markings. Mag. 200x.

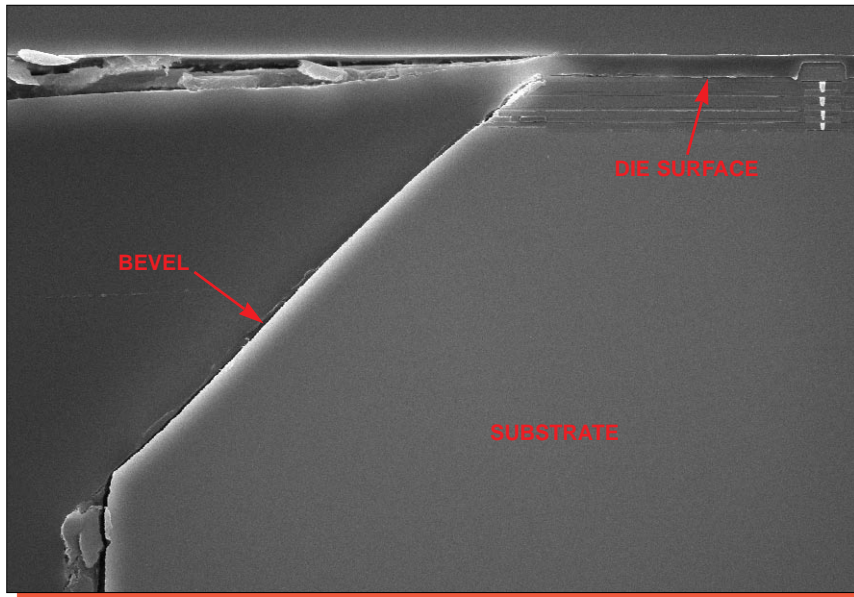
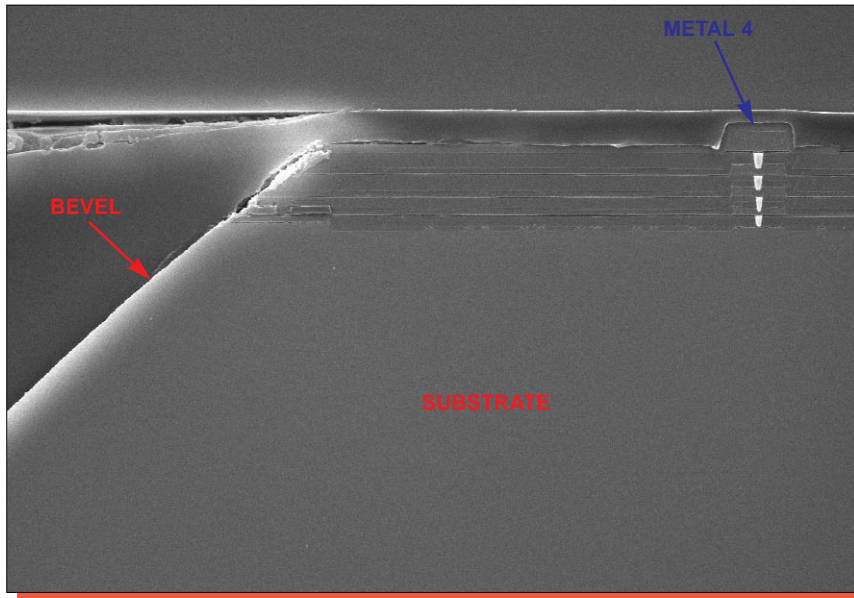
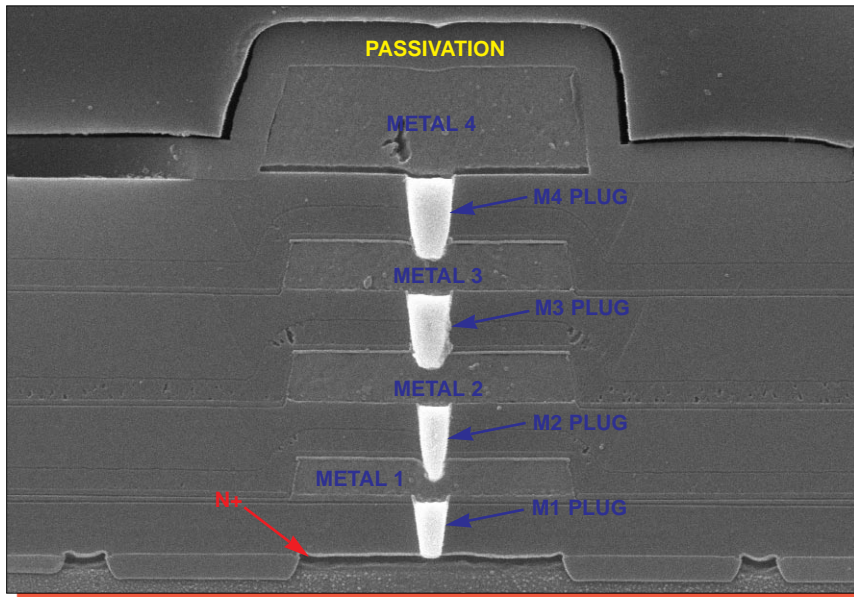
Figure 6. SEM section views of the edge seal structure.

- Die attach: Silver-epoxy die attach of good quality. No voids were noted in the die attach. The backside of the die was plated with gold.
- Die dicing: Die separation was by full depth sawing and showed normal quality workmanship. No large chips or cracks were present at the die edges. The edges of the die had been beveled (see Figure 6). This is highly unusual and we do not know why it is done (or how).

- Final passivation: A single layer of nitride. Coverage was good. Edge seal was also good as the passivation extended into the scribe lane to seal the metallization.

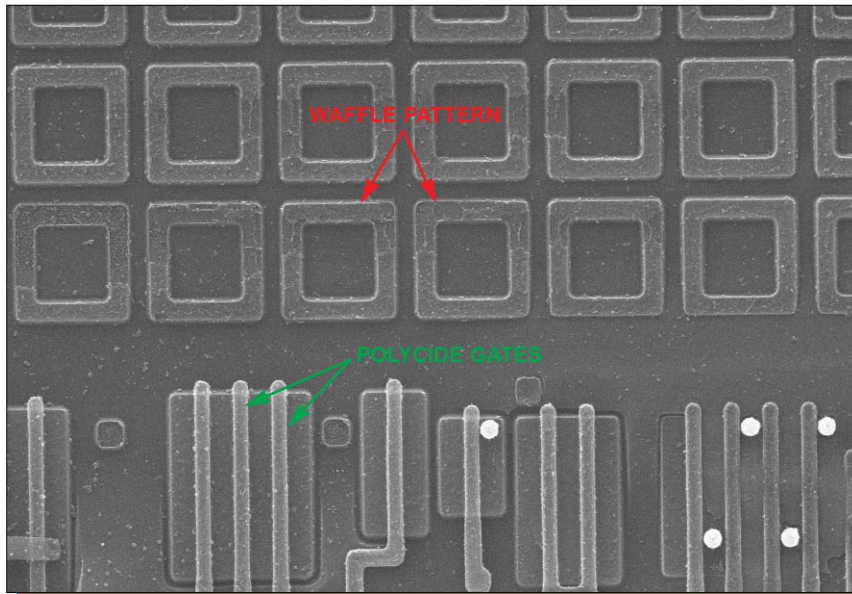
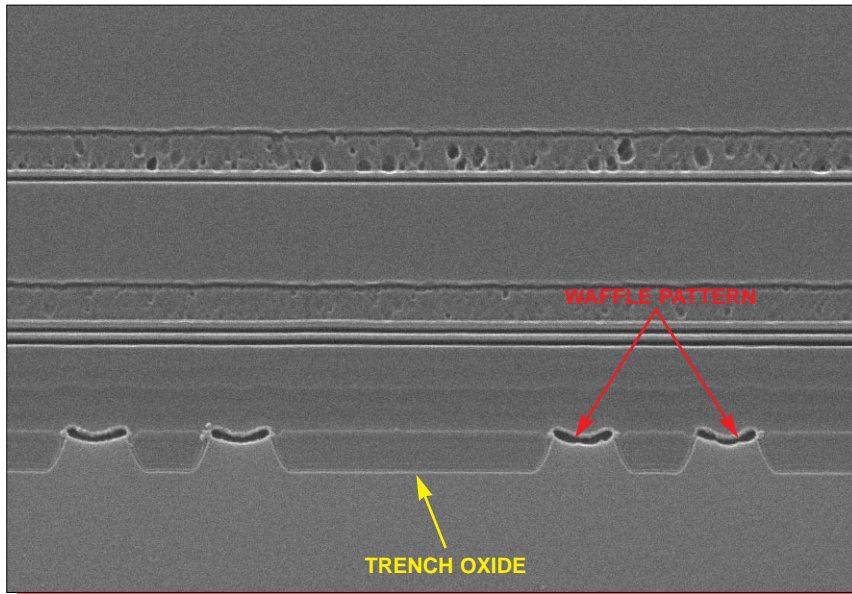
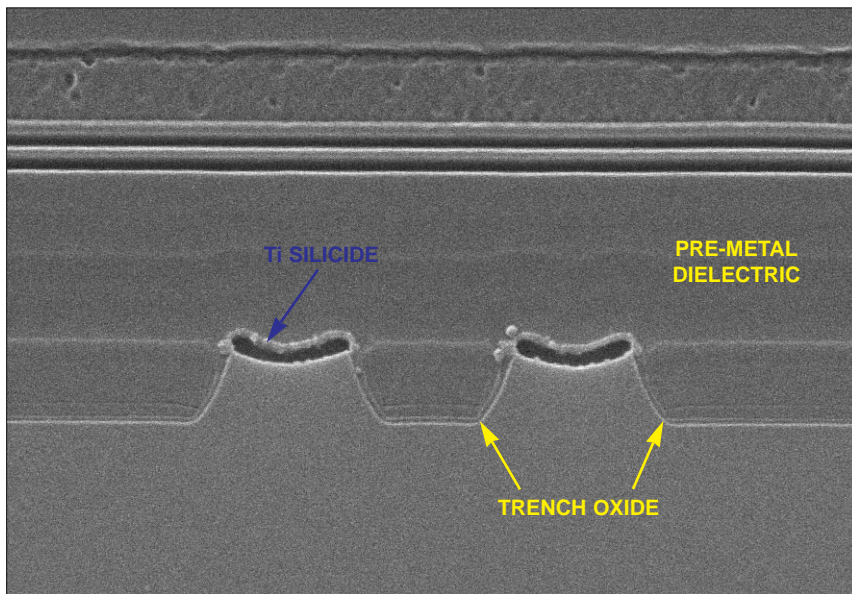
Figure 7. Topological and section views illustrating planarizing pattern.

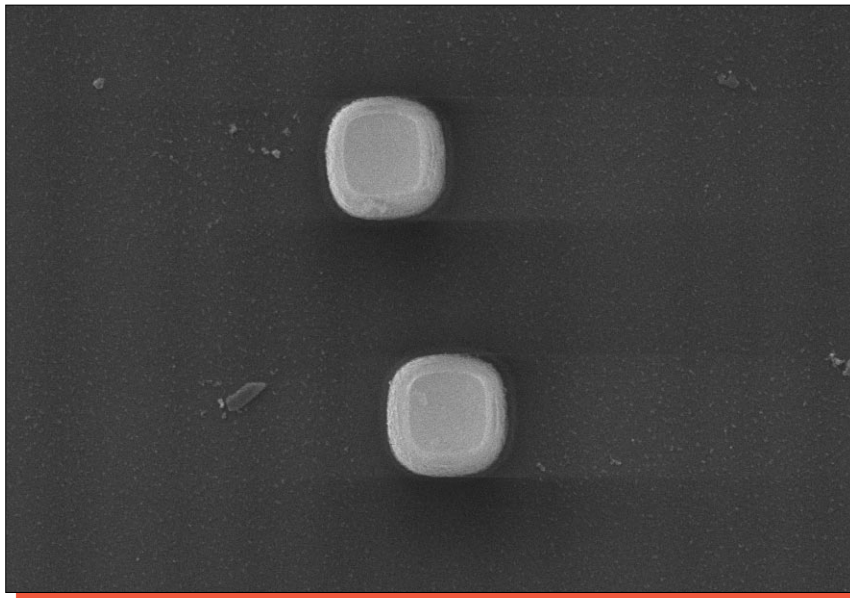
Figure 8. Optical and SEM views illustrating non-connected vias.

- Fabrication process: Oxide-filled shallow-trench isolation, CMOS process apparently employing twin-wells in an N-epi on an N substrate. No problems were found in the process.
- Design implementation: Die layout was clean and efficient. Alignment was good at all levels.
- Design features: Slotted bus lines were employed to relieve stress. Anti-dishing patterns were employed for planarization purposes. Numerous unconnected metal 4 vias which appear to be used for probing purposes were present.

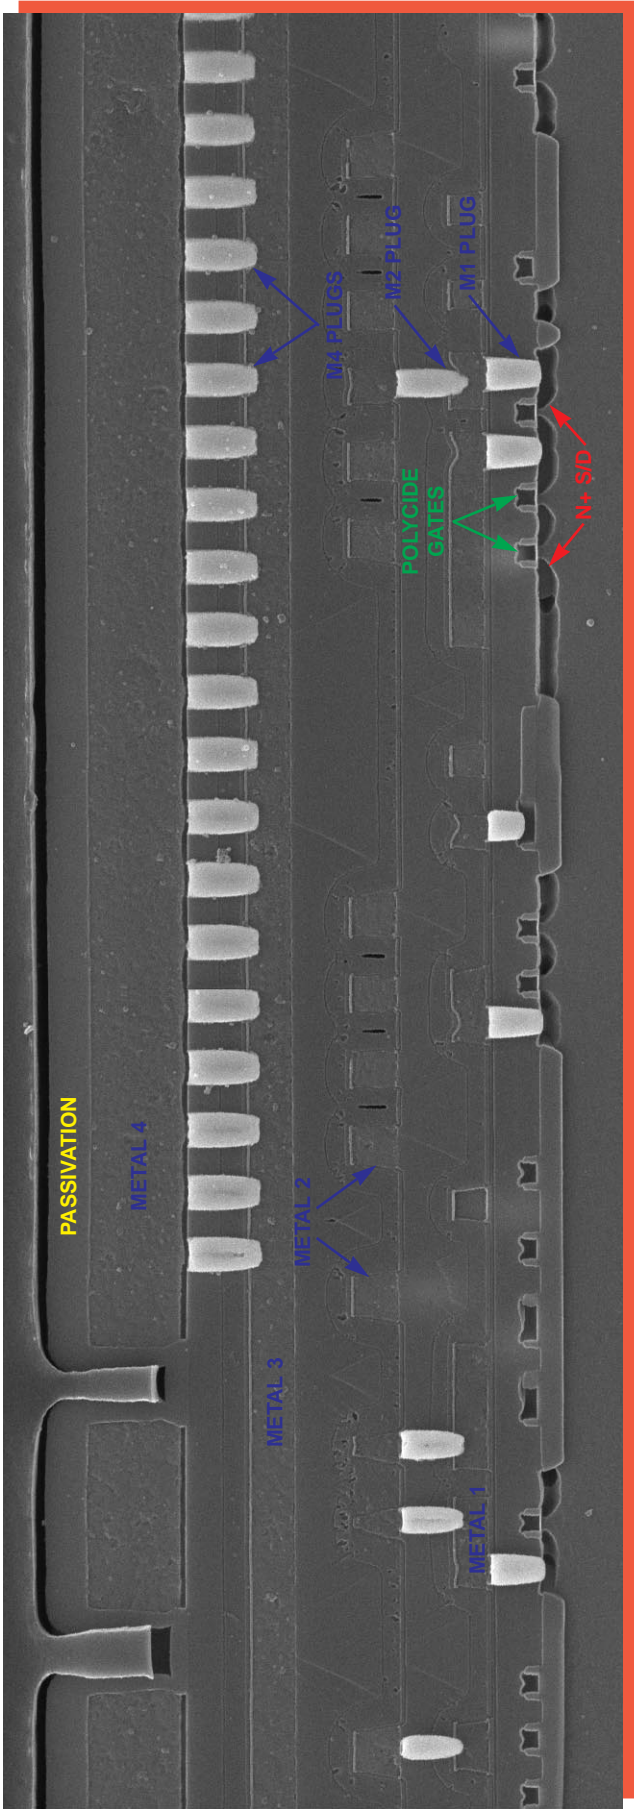
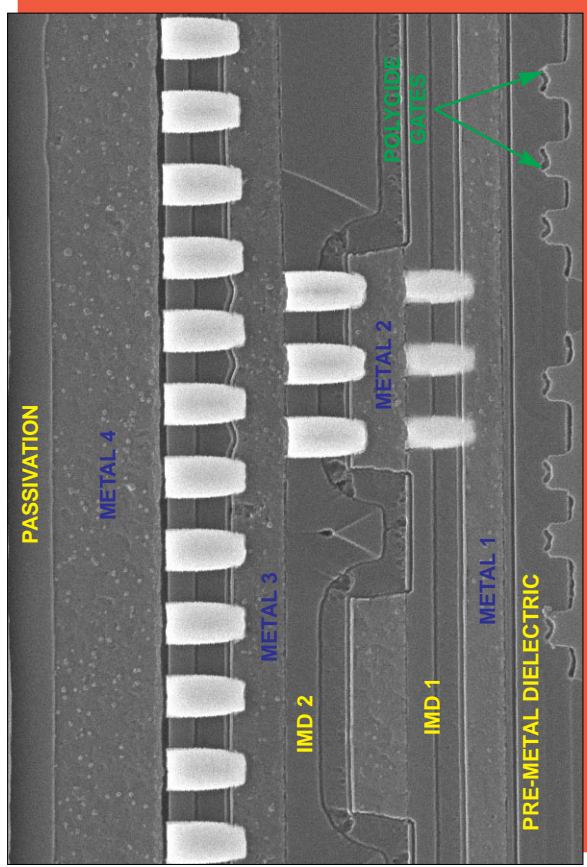
Figure 9. SEM section views illustrating general device structure.

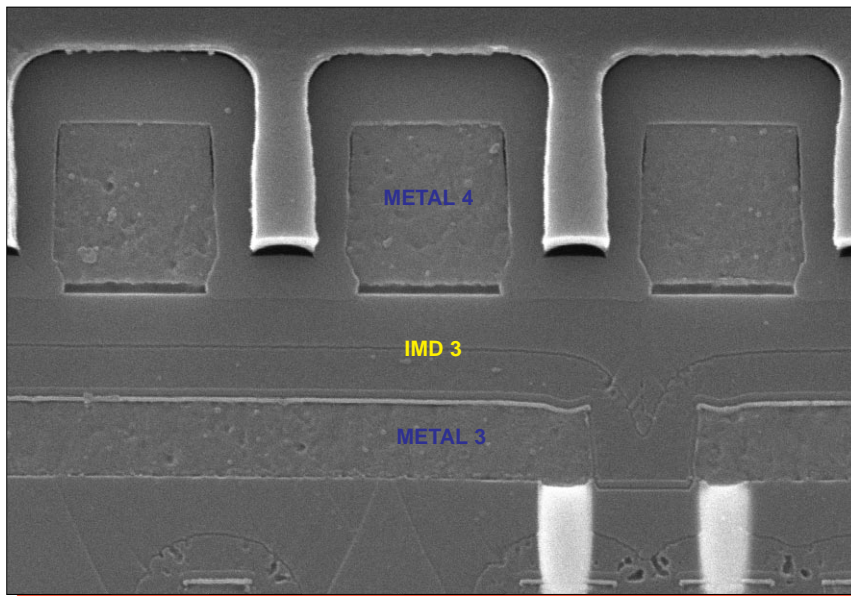
Figure 10. SEM section views of metal 4 line profiles.

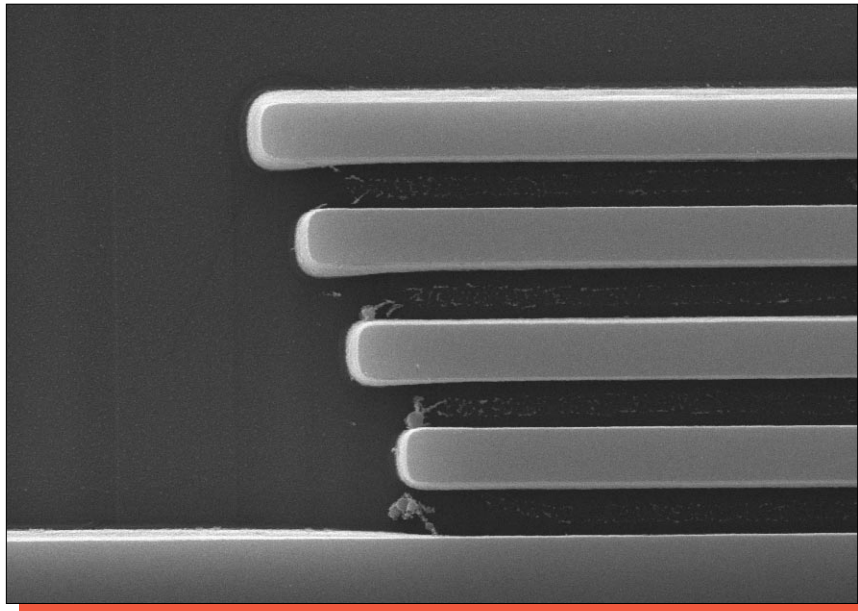
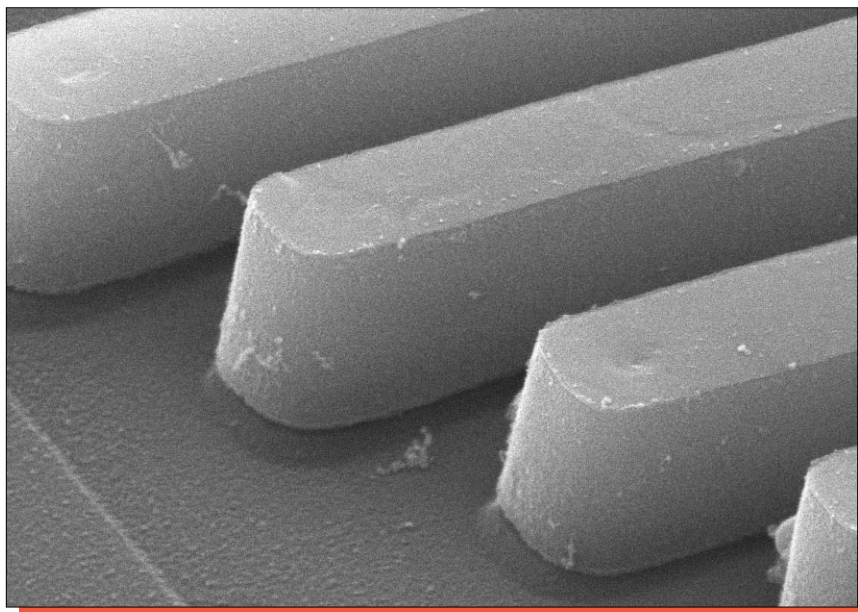
Figure 11. SEM views of metal 4 patterning and coverage.

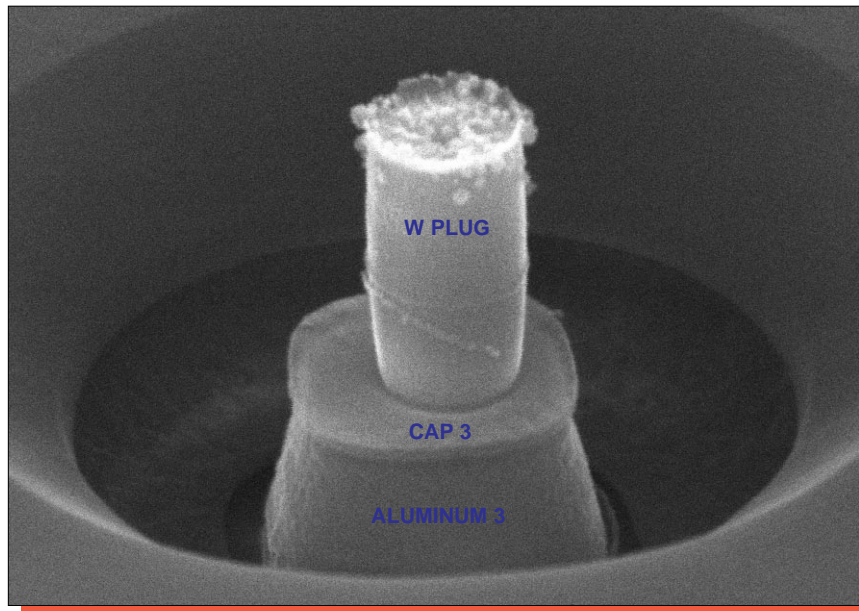
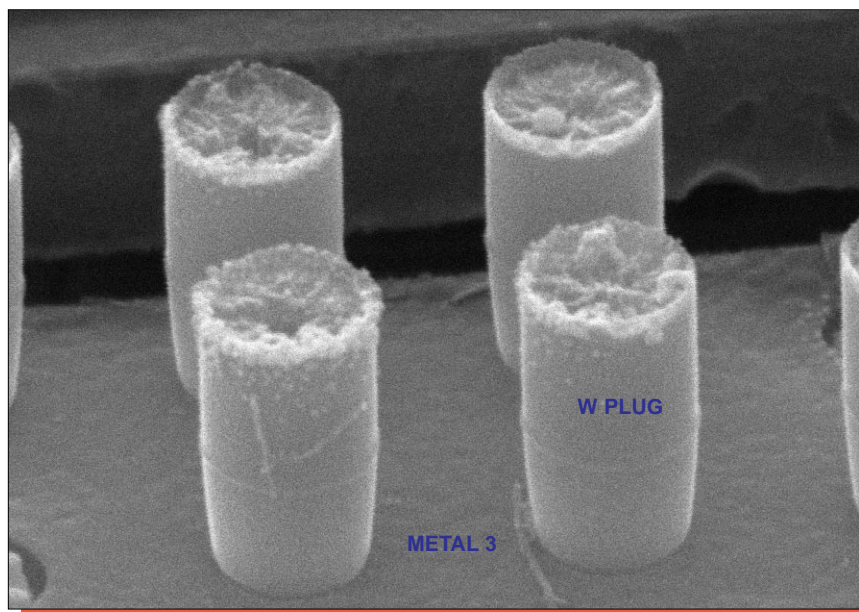
Figure 12. SEM views of metal 4 tungsten plugs. 55°.

- Metallization: Four levels of metallization. All consisted of aluminum with titanium-nitride caps. Metal 4 employed a fairly thick titanium adhesion layer. The other levels probably used a titanium layer too thin to detect. Tungsten plugs were employed with all metals. Holes were noted in the center of some tungsten plugs at metals 2-4. All plugs were lined with titanium-nitride underneath and the presumed titanium layer over top.

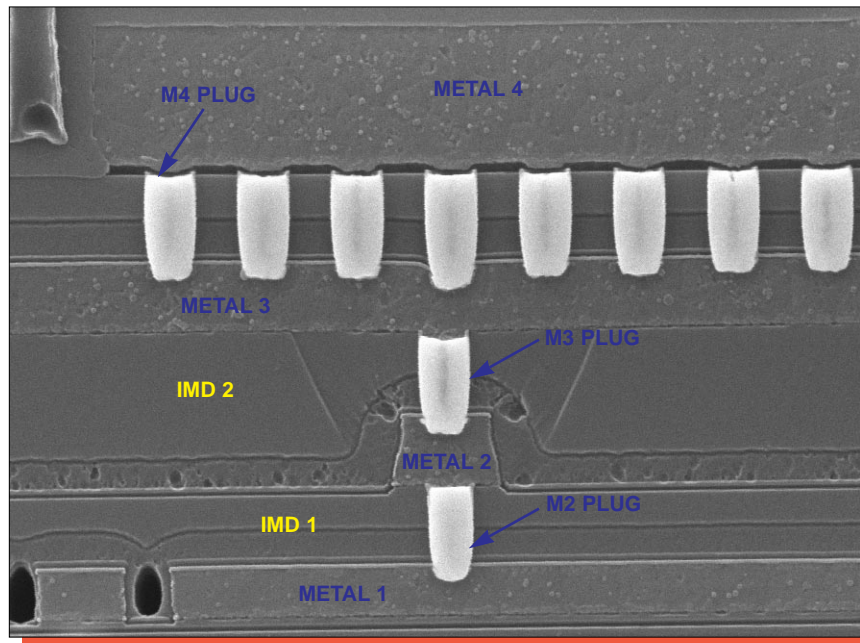
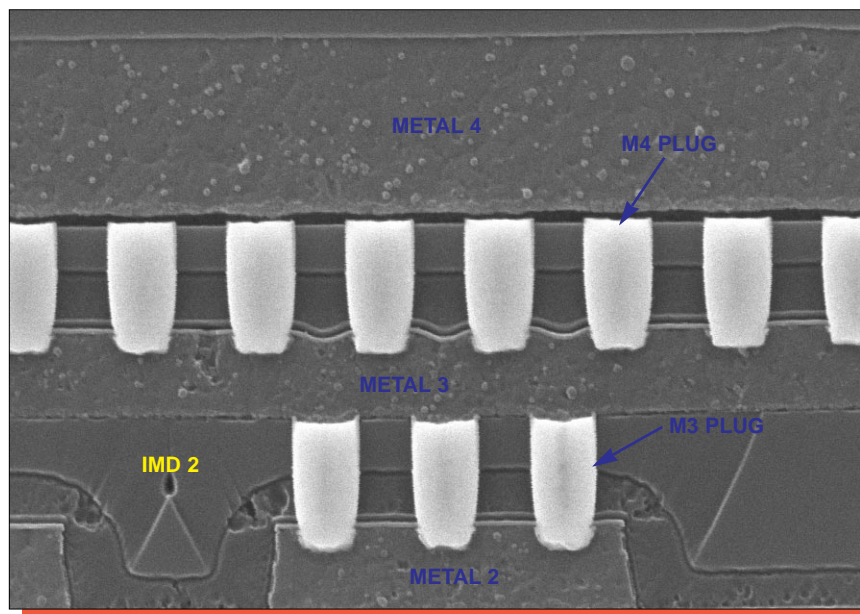
stacked vias, Mag. 11,000x

Figure 13. SEM section views of metal 4-to-metal 3 vias.

- Vias and contacts: All via and contact cuts were defined by a dry and wet-etch of good quality. Again, alignment of the metals and plugs was very good. Metals 2 - 4 employed tungsten "stubs" at the bottom of the tungsten plugs. These unique features consisted of stubs of tungsten plug metallization that penetrated into the underlying aluminum. It is assumed that this represents a method to obtain good contact. Vias and contacts were placed directly over one another (stacked vias). No problems were noted.

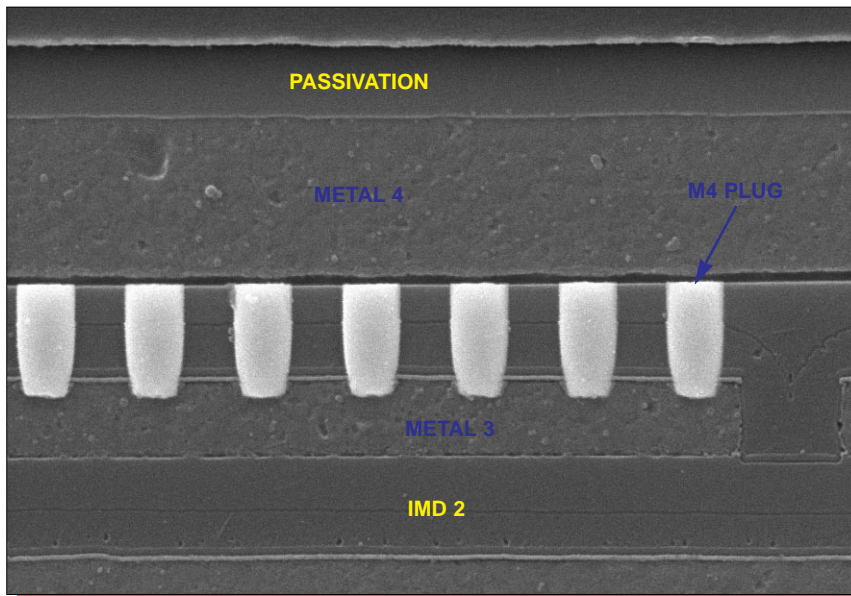
Figure 14. Additional SEM section views of metal 4-to-metal 3 vias.

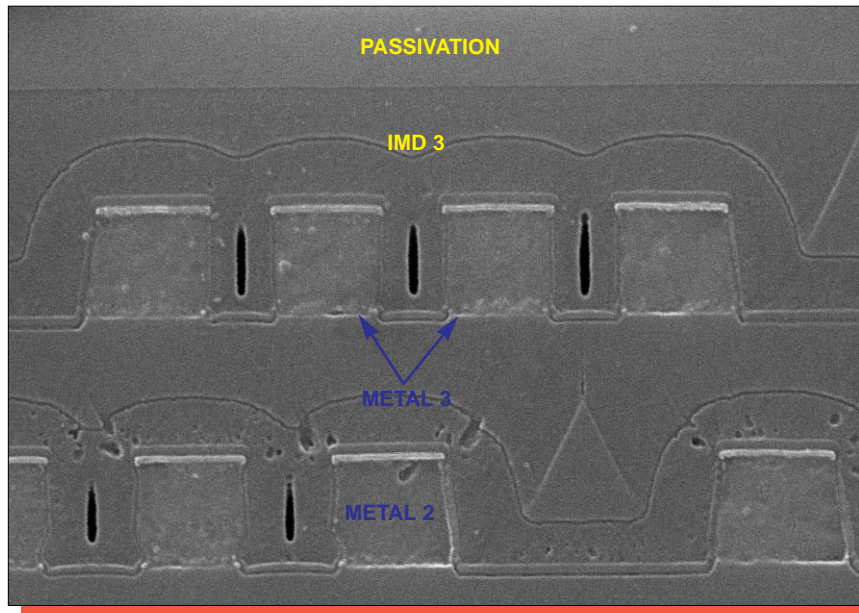
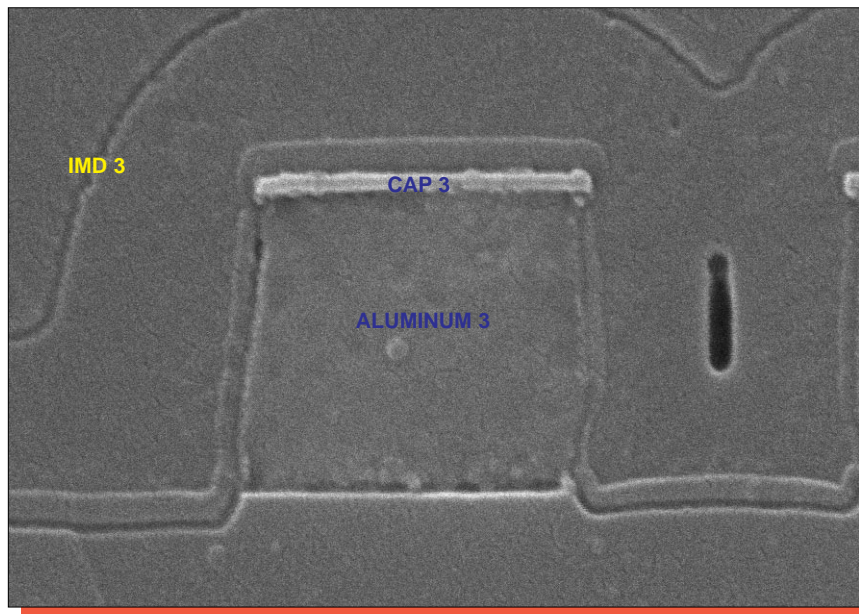
Figure 15. SEM section views of metal 3 line profiles.

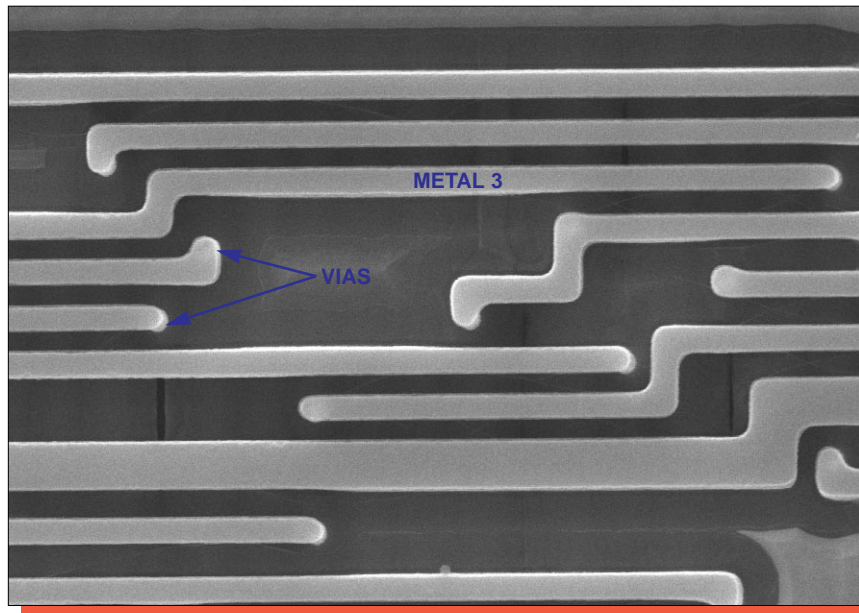
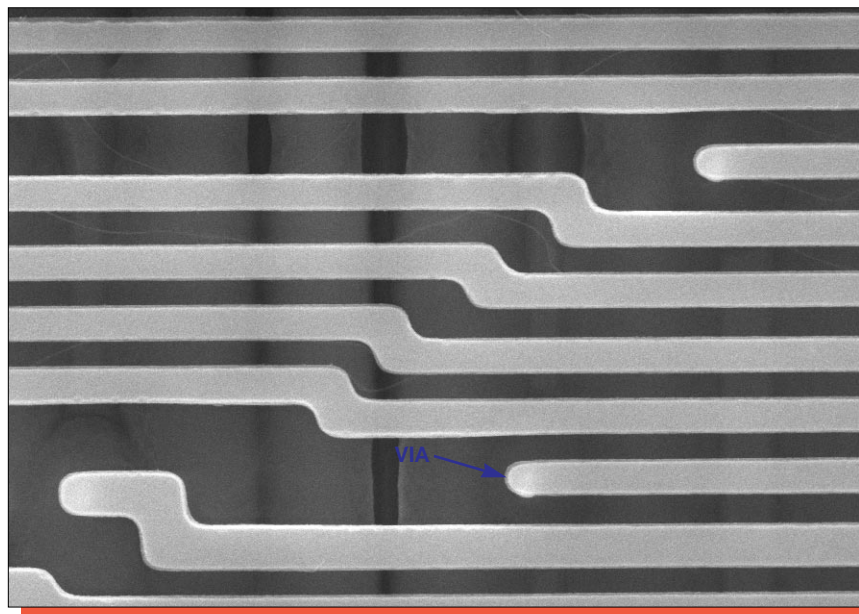
Figure 16. Topological SEM views of metal 3 patterning. 0°.

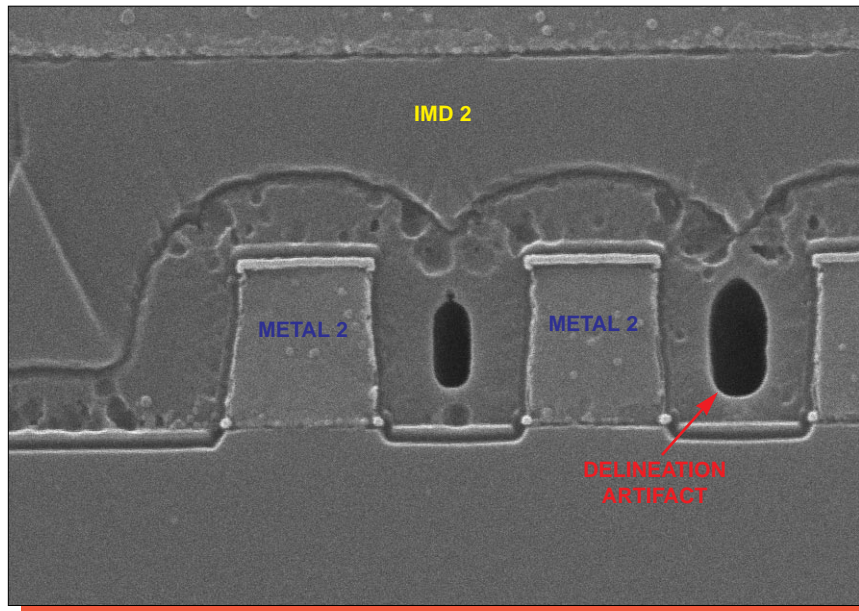
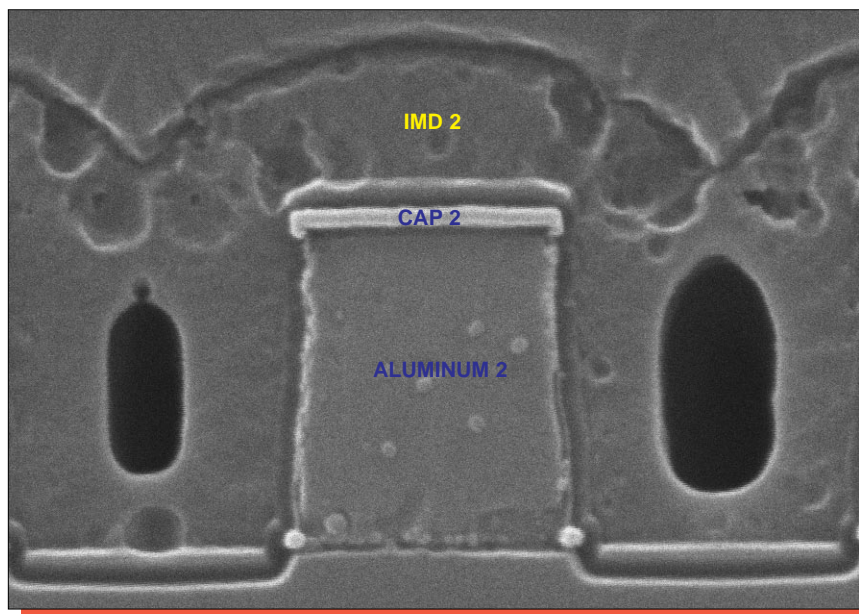
Figure 20. SEM section views of metal 2 line profiles.

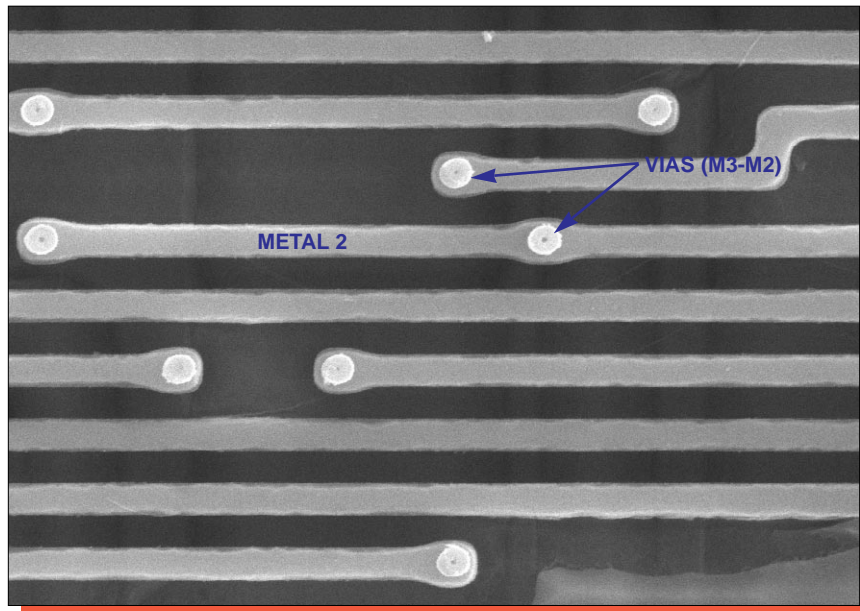
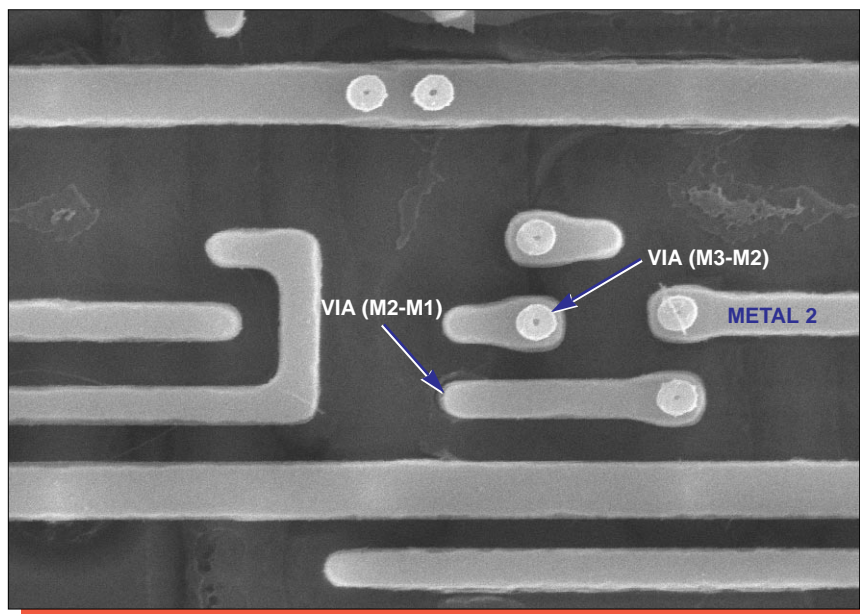
Figure 21. Topological SEM views of metal 2 patterning. 0°.

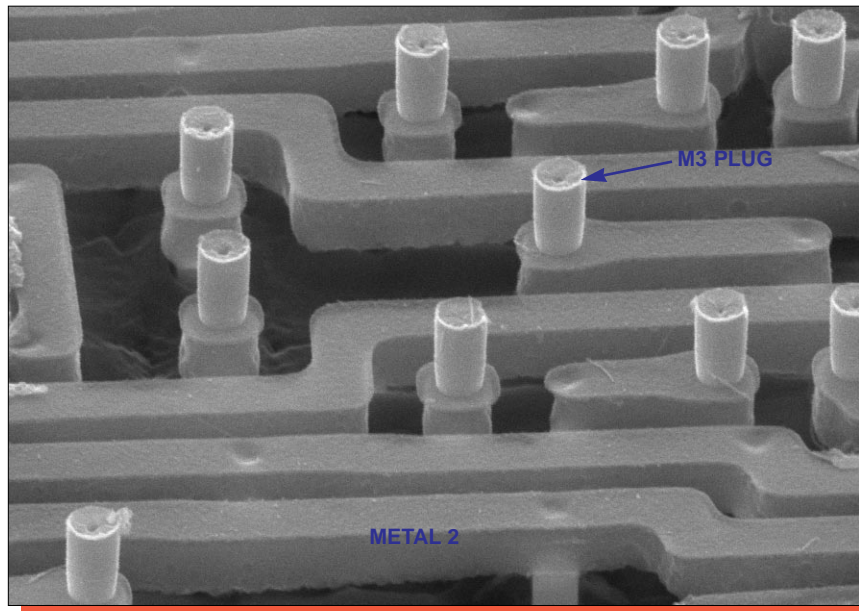
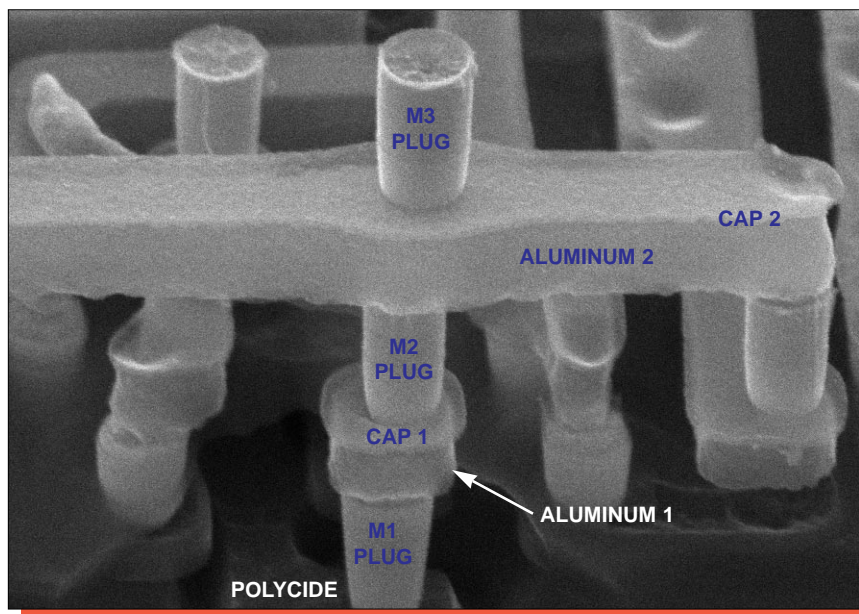
Figure 22. SEM views of general metal 2 coverage. 55°.

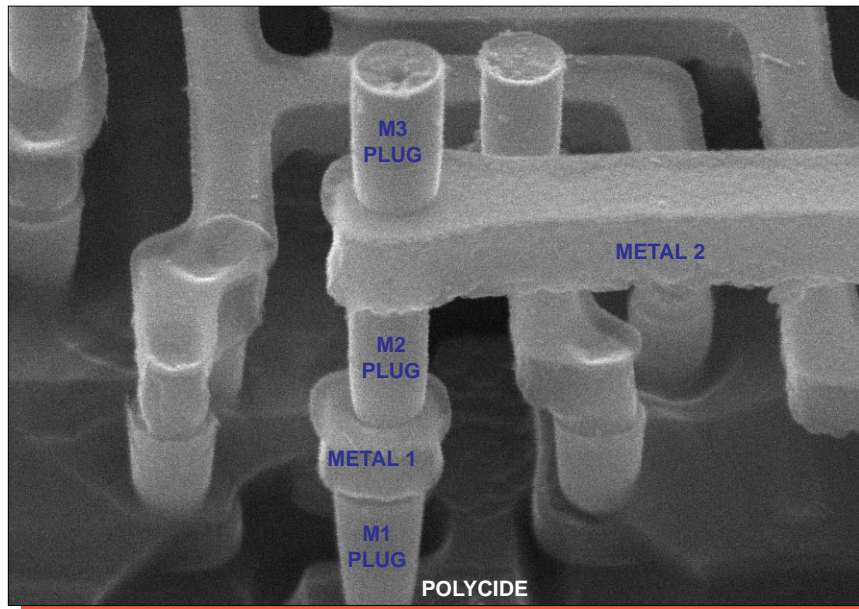
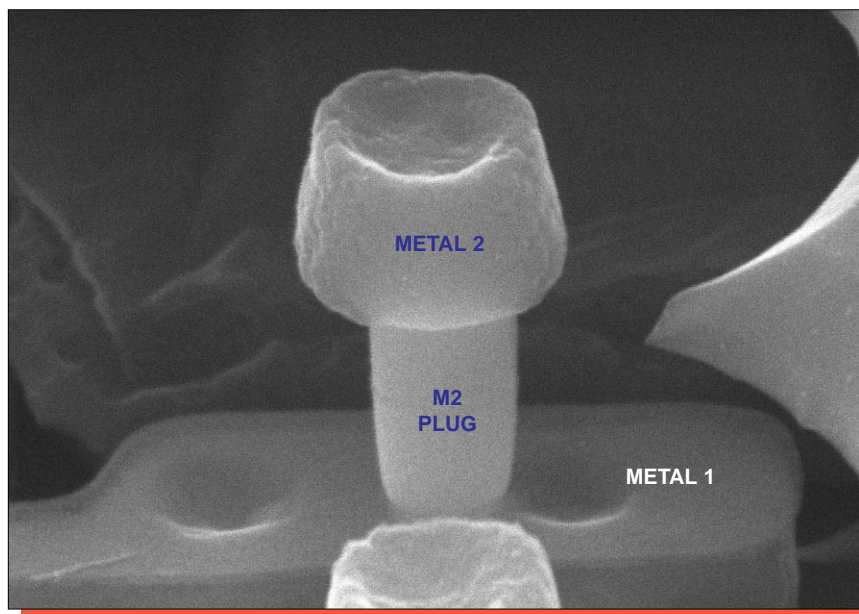
Figure 22a. SEM details of metal 2 coverage. 55°.
