Construction Analysis

Intel Pentium Processor W/MMX

Report Number: SCA 9706-540

INTEGRATED CIRCUIT ENGINEERING

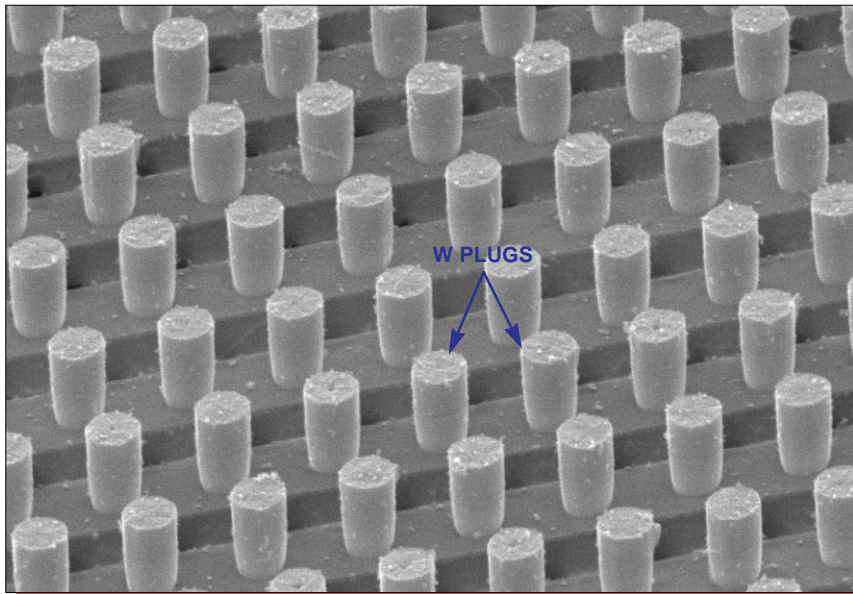
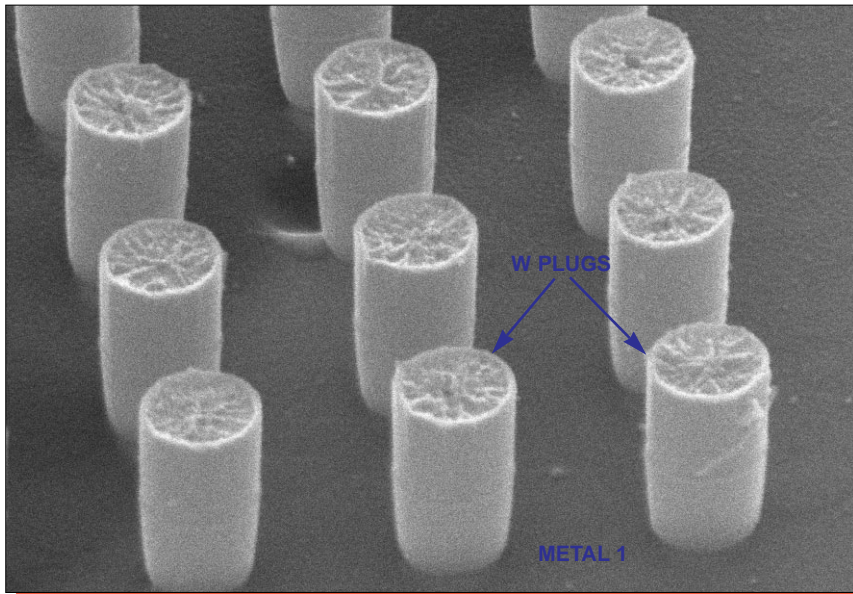
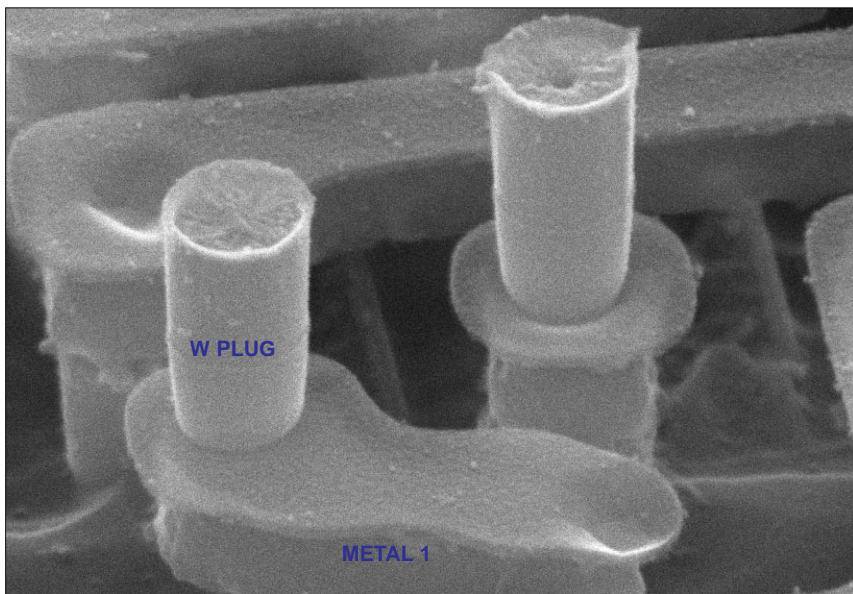
Figure 23. SEM views of metal 2 tungsten plugs. 55°.

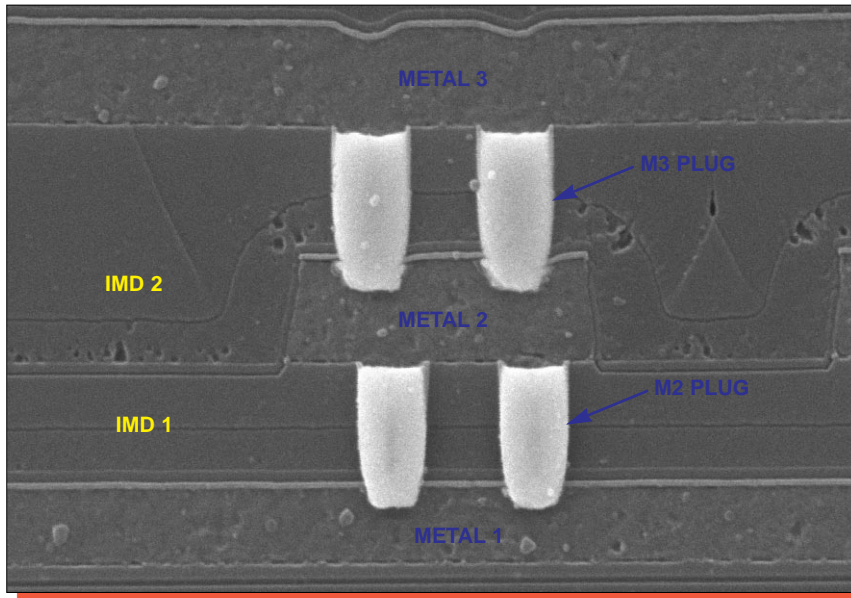
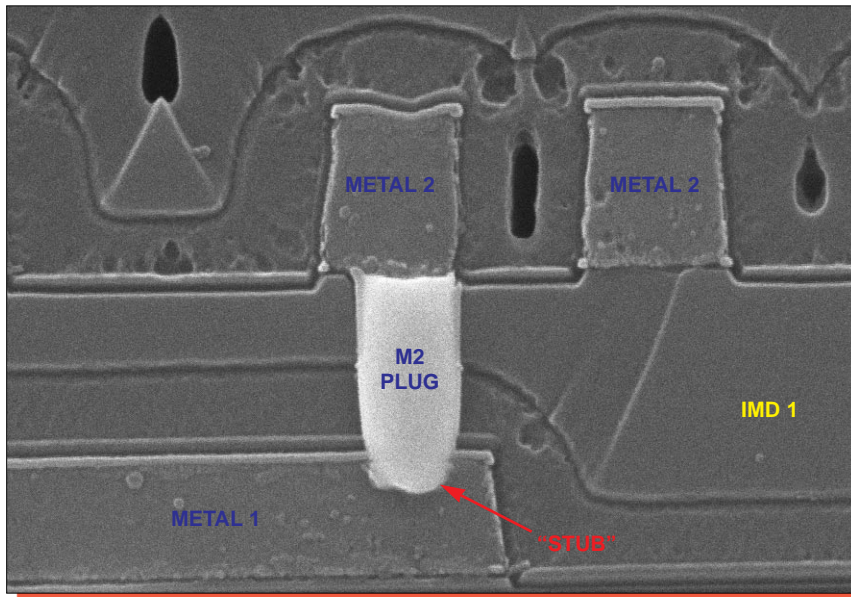
Figure 24. SEM section views of metal 2-to-metal 1 vias.

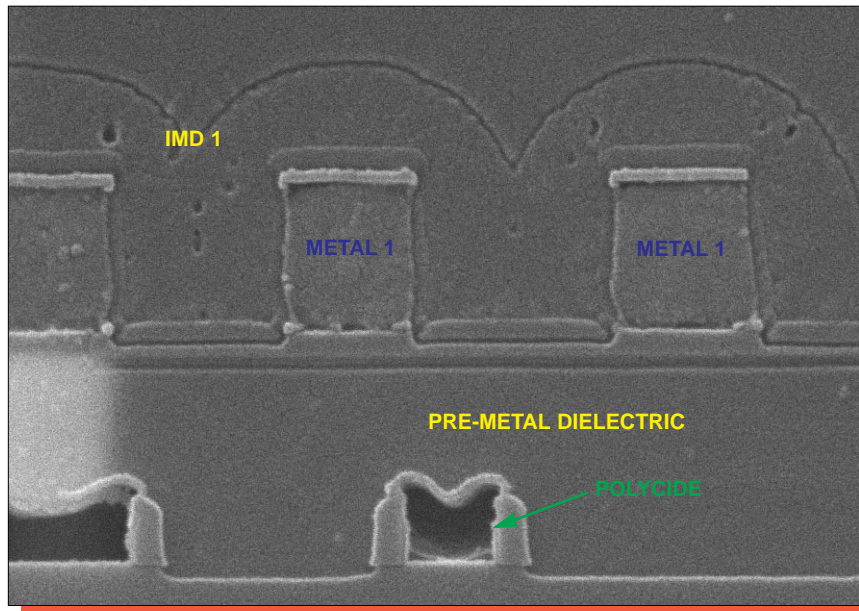
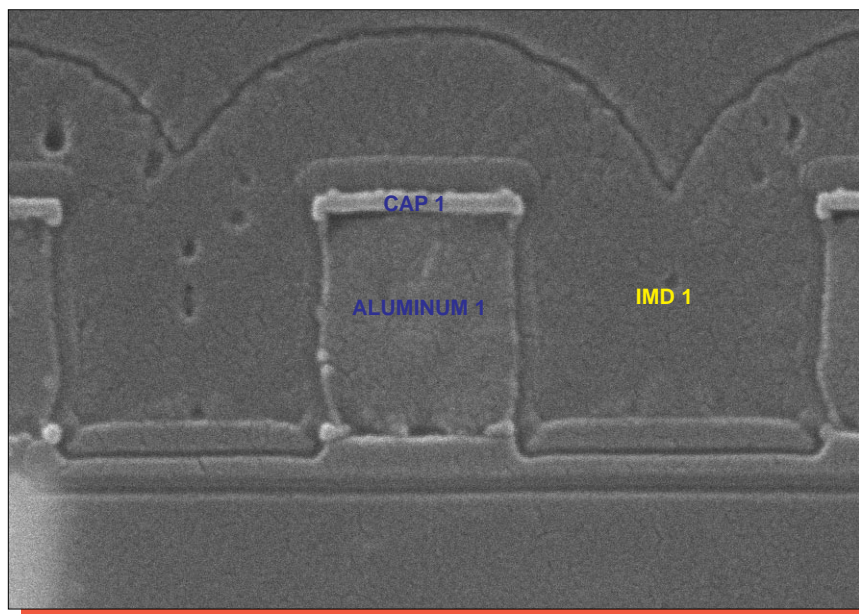
Figure 25. SEM section views of metal 1 line profiles.

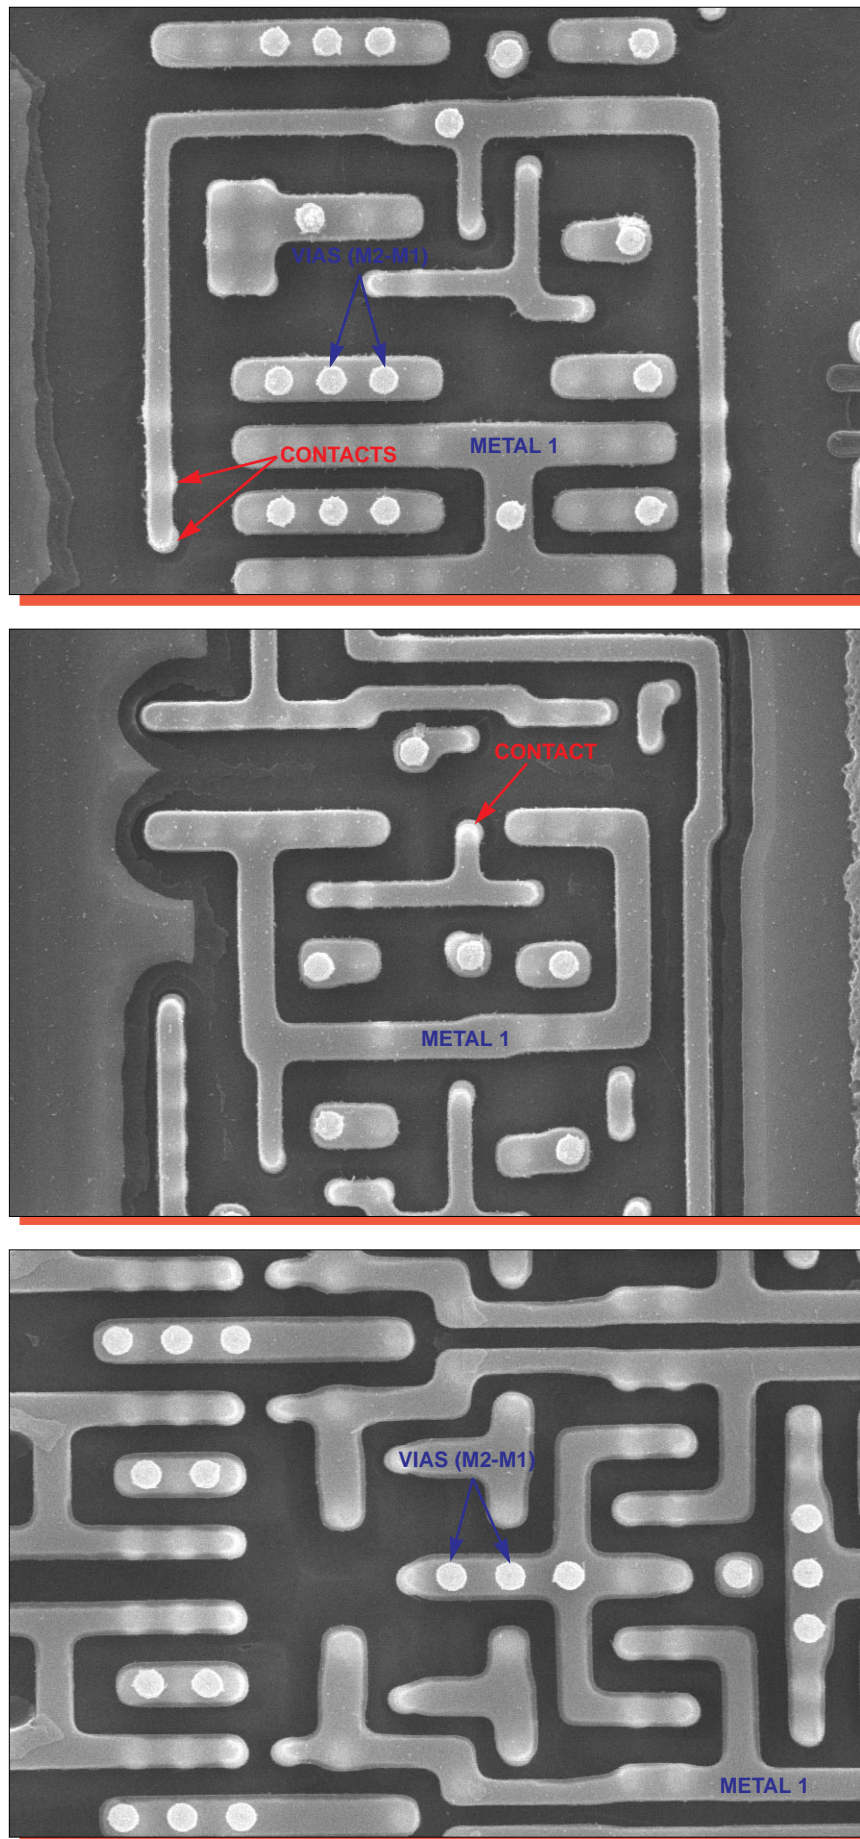
Figure 26. Topological SEM views of metal 1 patterning. Mag. 6500x, 0°.

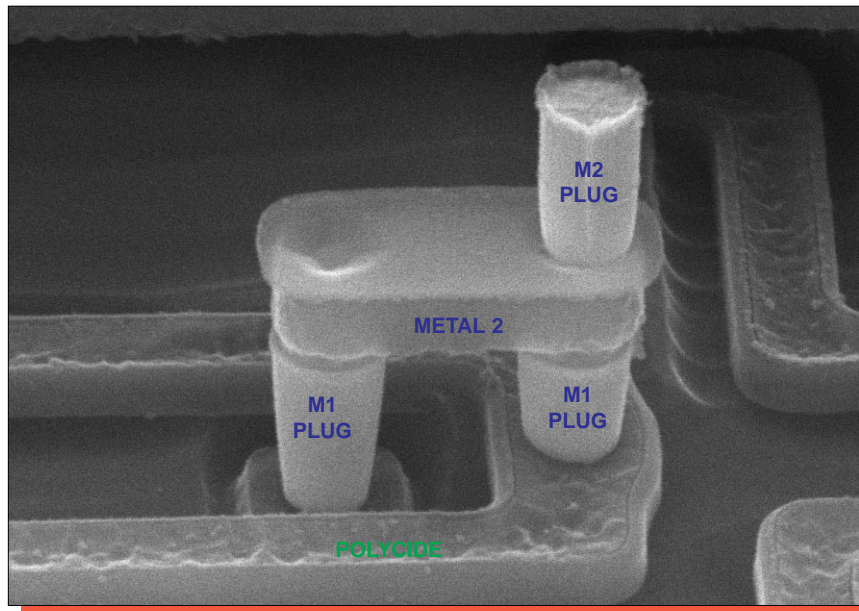
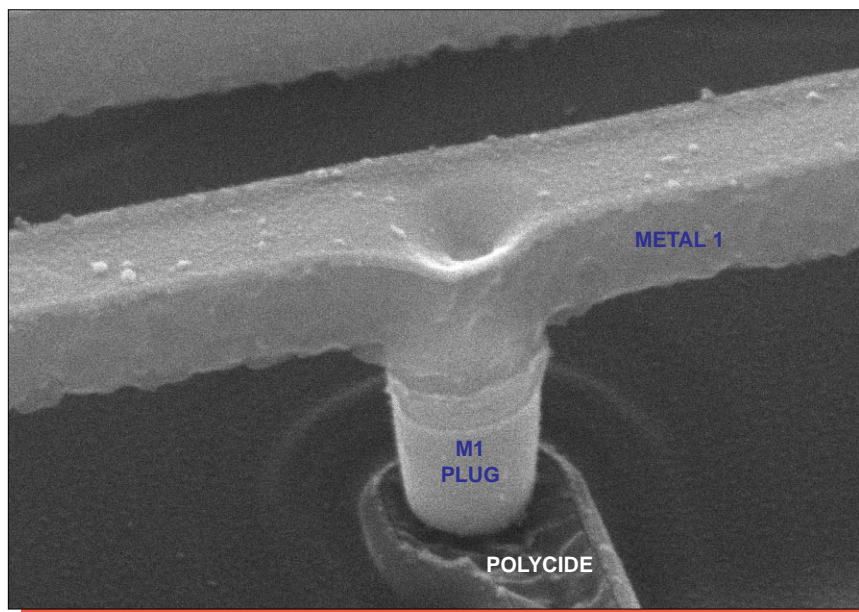
Figure 28. SEM details of metal 1 coverage. 55°.

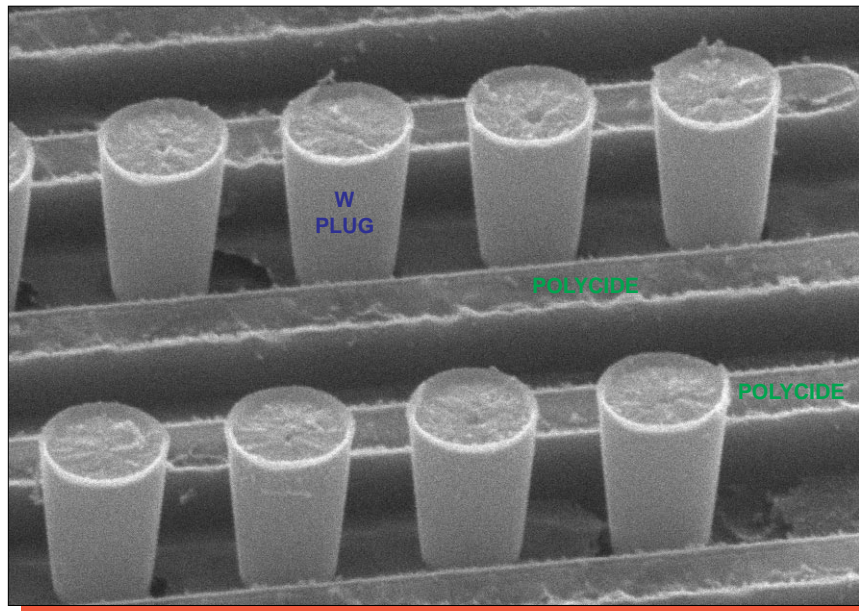
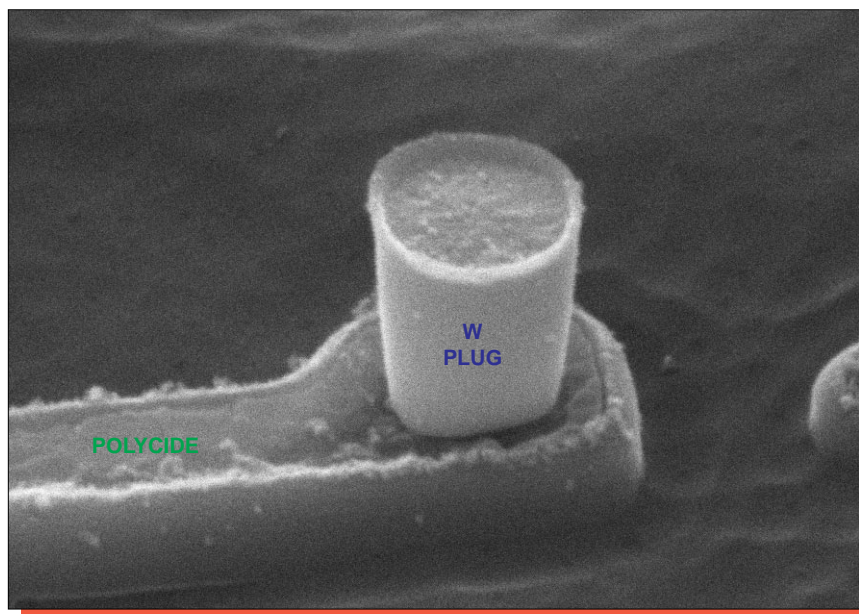
Figure 29. SEM views of metal 1 plugs. 55°.

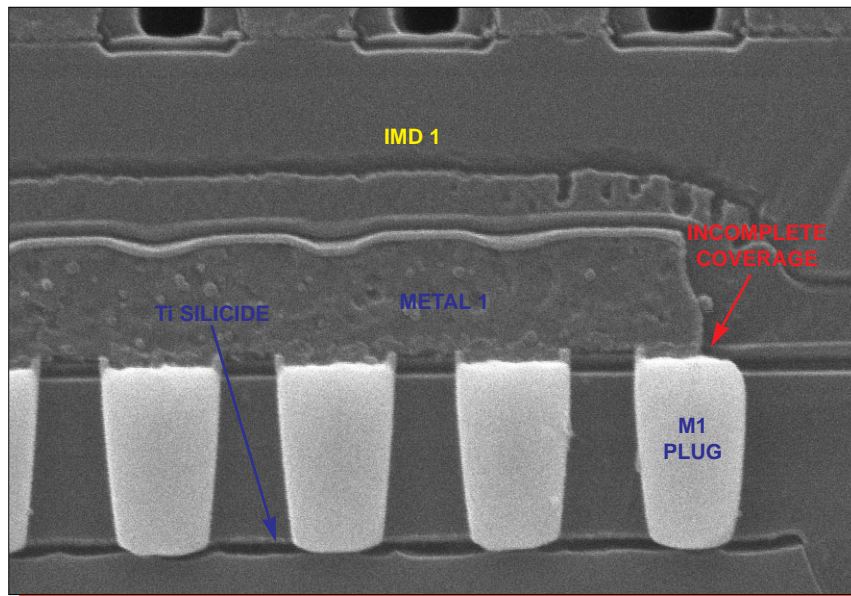
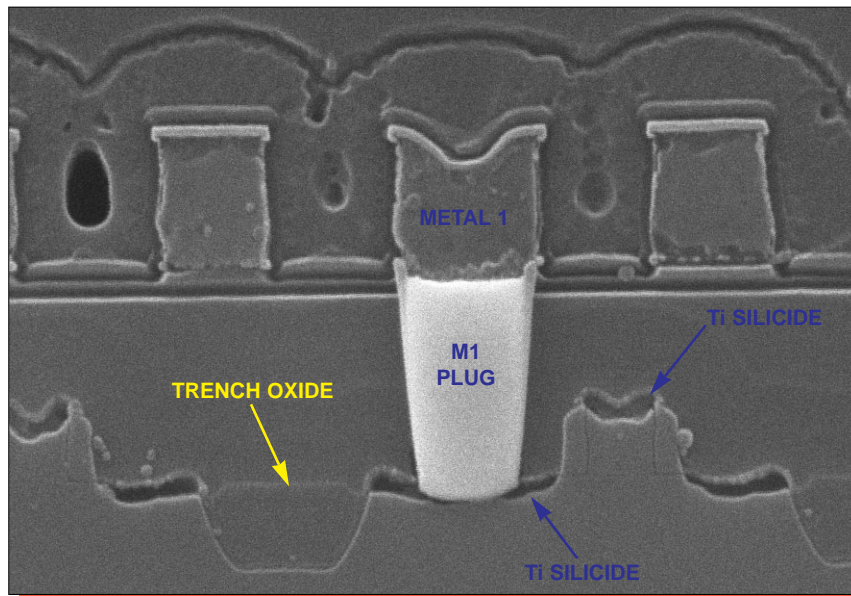
Figure 30. Glass etch section views of metal 1 contacts.

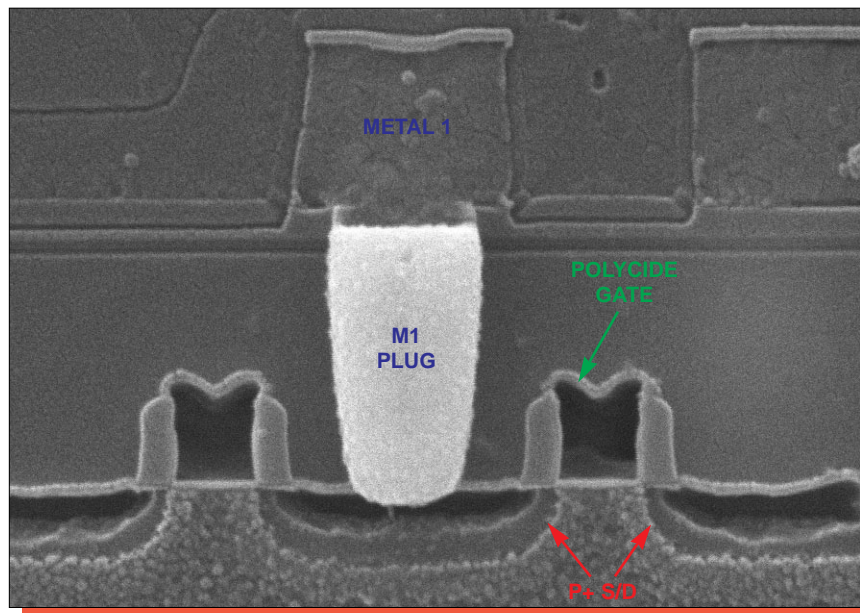
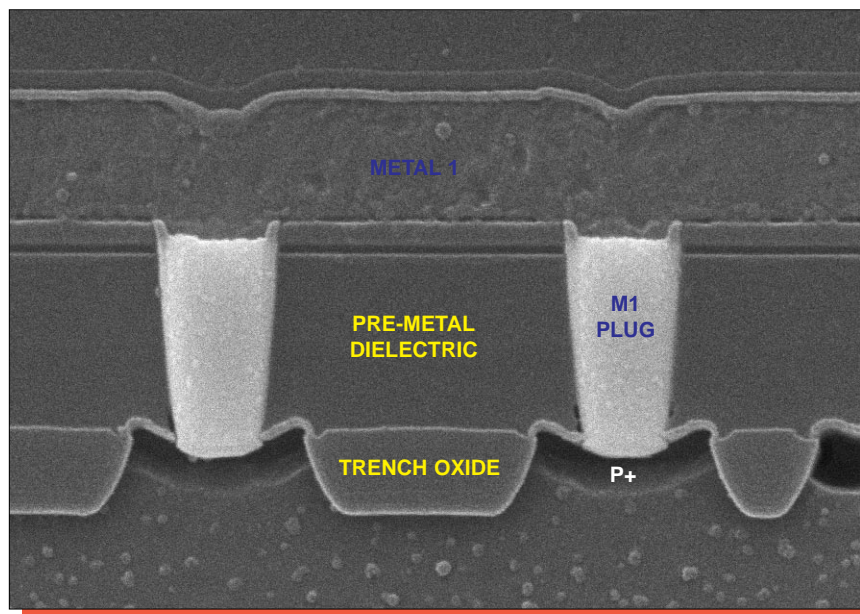
Figure 33. SEM section views of metal 1-to-P+ contacts.

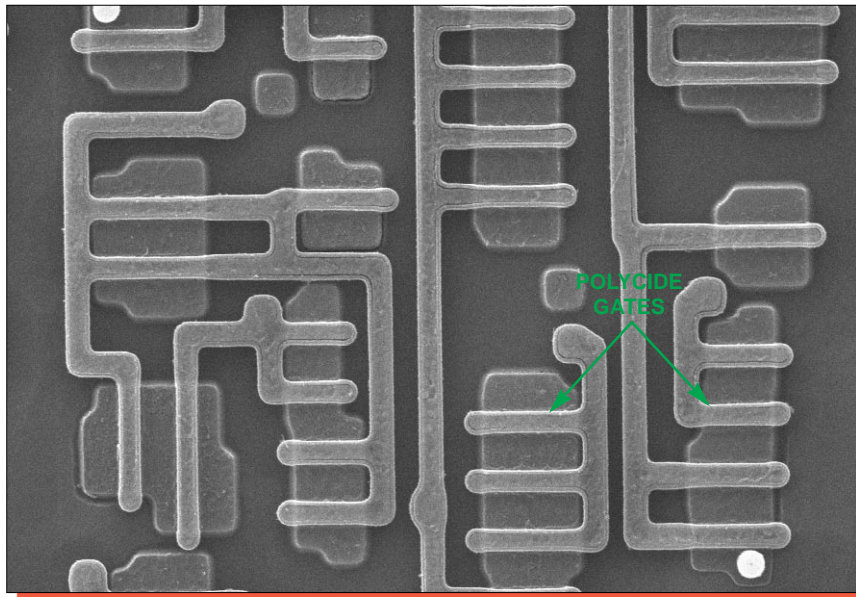
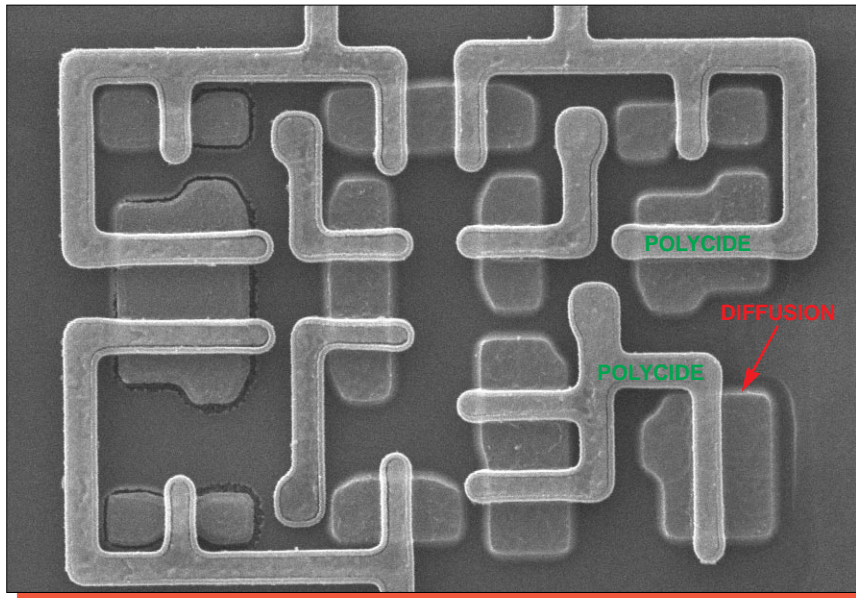
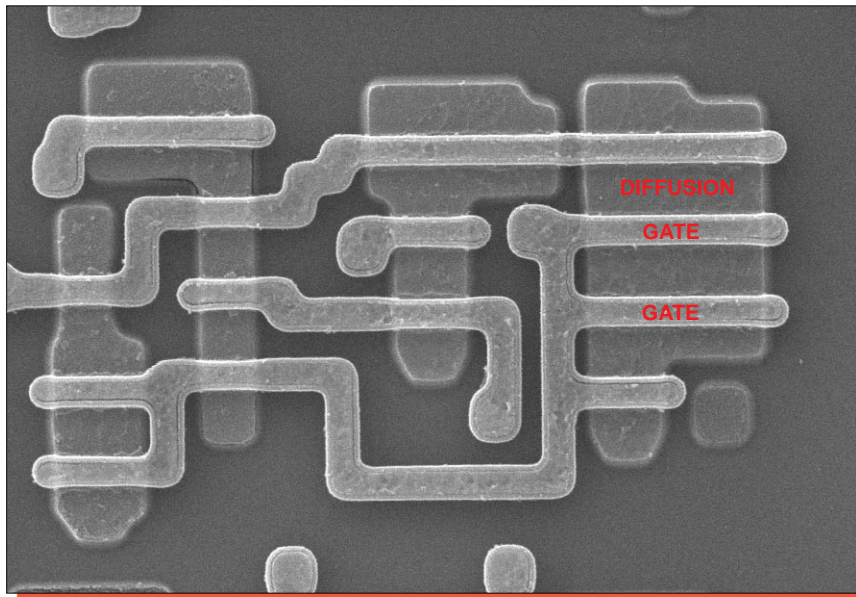
Figure 34. Topological SEM views of polycide gates. 0°.

- Polysilicon: A single level of polycide (poly and titanium-silicide) was used. It formed all gates and word lines in the array. Definition was by a dry etch of good quality. Nitride sidewall spacers were used throughout and left in place. No problems were found.

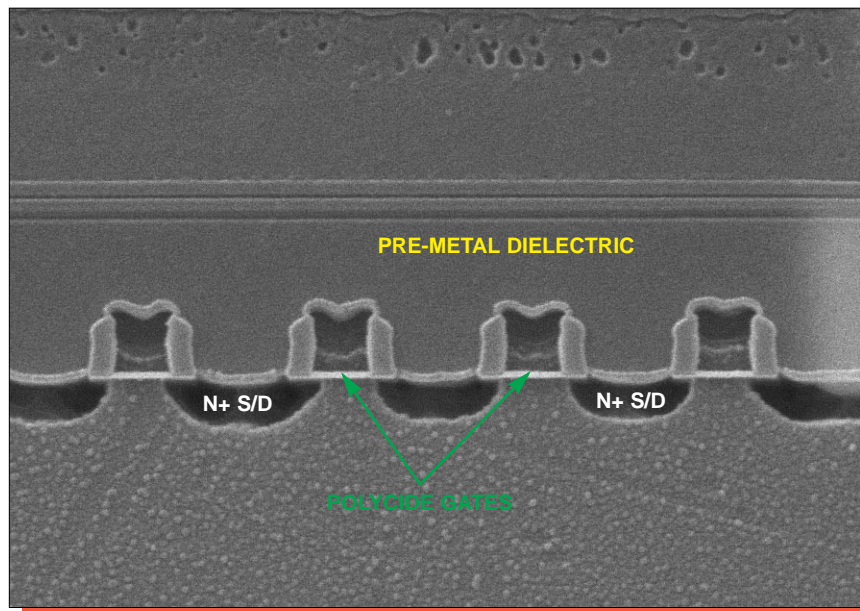
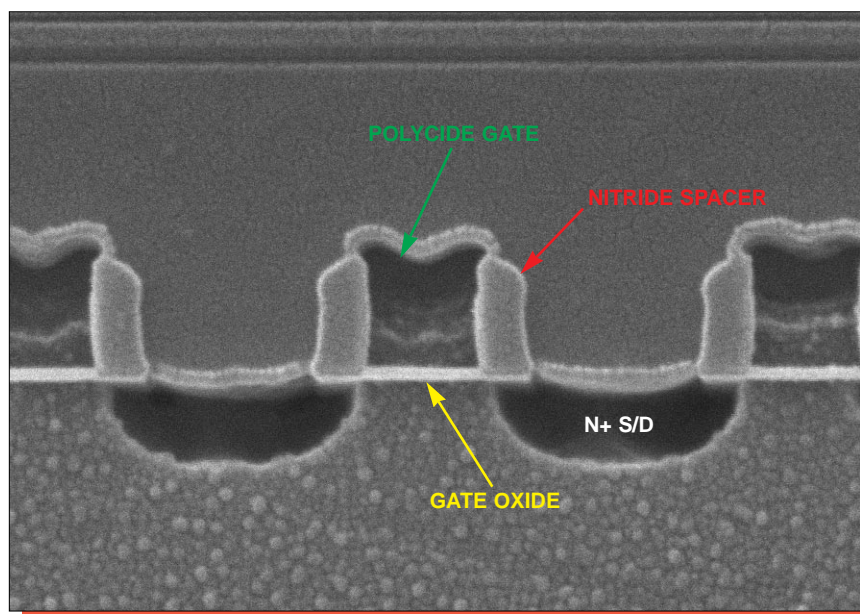
Figure 36. SEM section views of N-channel transistors.

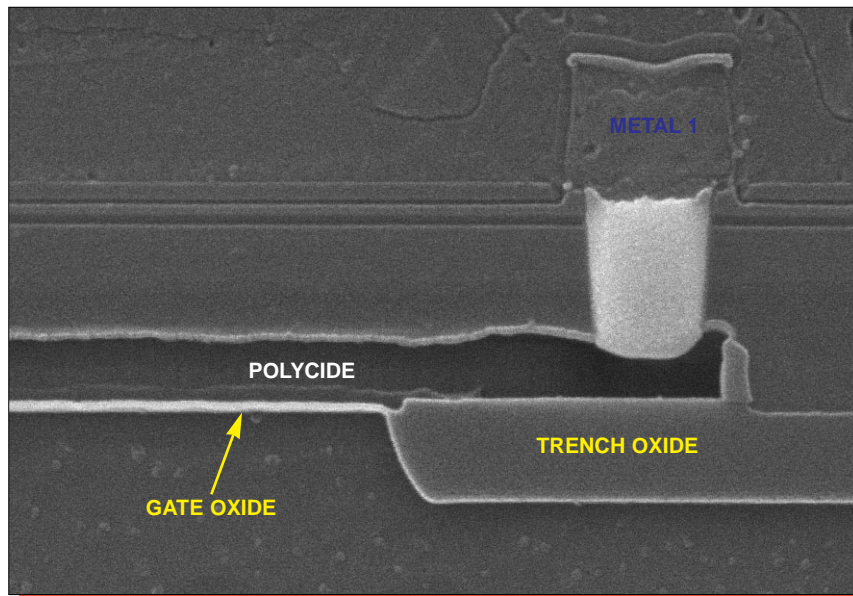
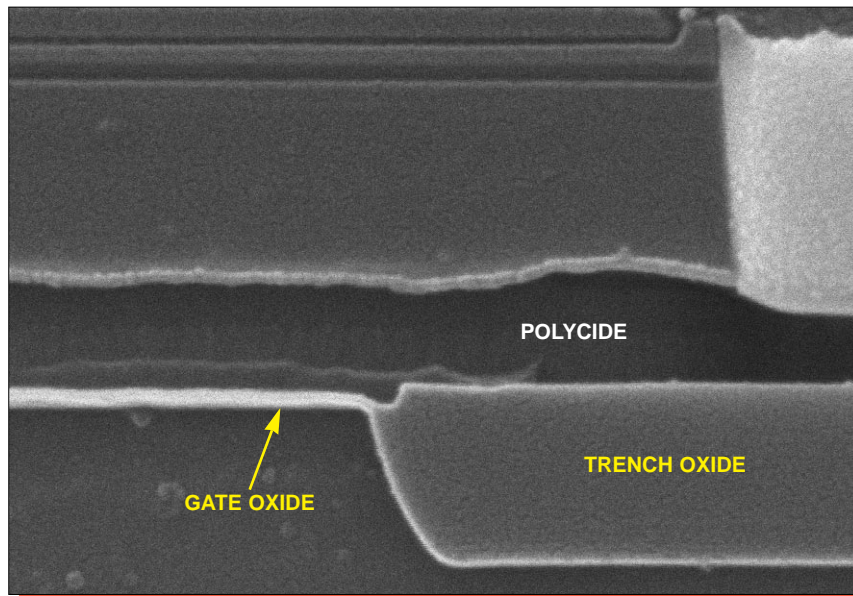
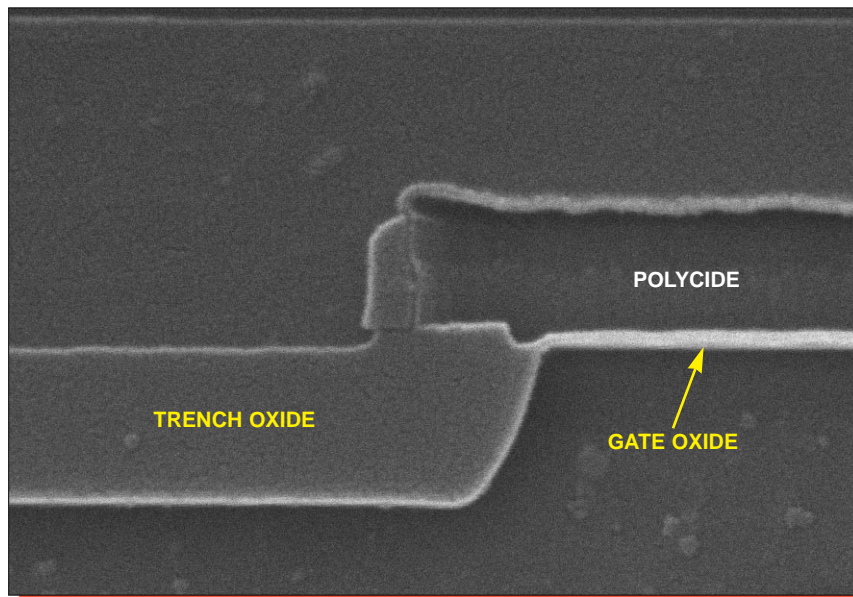
Figure 38. SEM section views of trench oxide isolation.

- Isolation: The device used oxide-filled shallow-trench isolation which was quite planar with the silicon surface. No problems were present.
- Diffusions: Implanted N+ and P+ diffusions were used for sources and drains. Titanium was sintered into the diffusions (salicide process) to reduce series resistance. An LDD process was used employing nitride sidewall spacers. No problems were found.

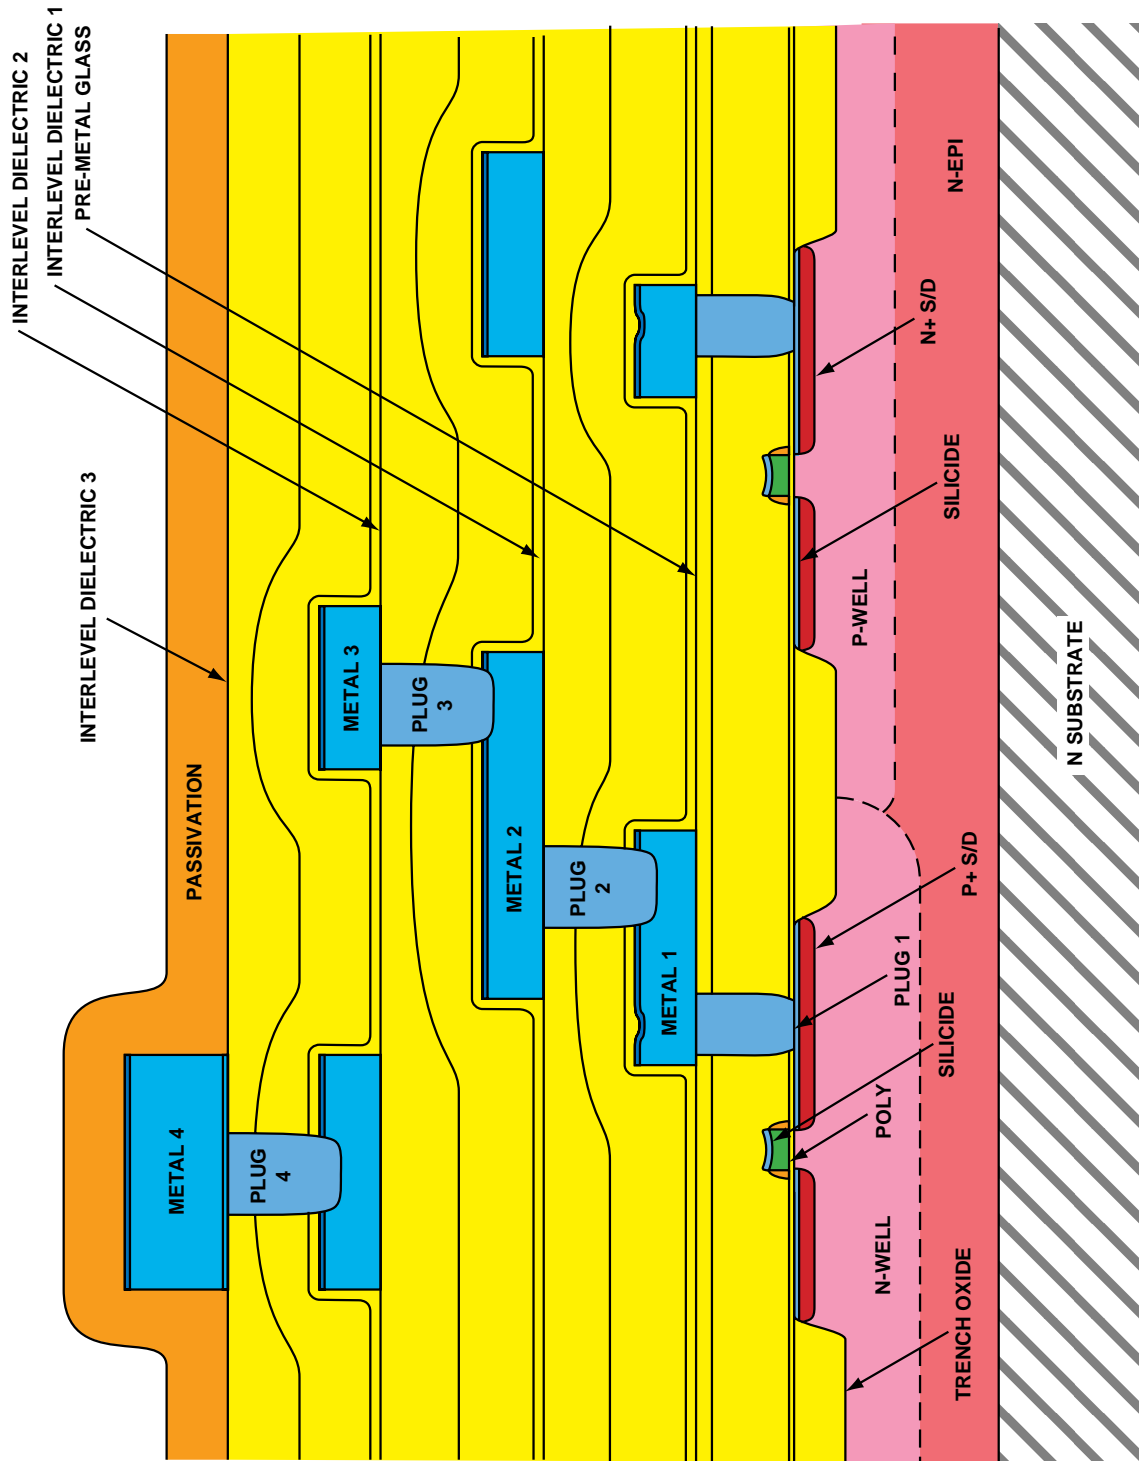
Orange = Nitride, Blue = Metal, Yellow = Oxide, Green = Poly,
 Red = Diffusion, and Gray = Substrate

Figure 40. Color cross section drawing illustrating device structure.

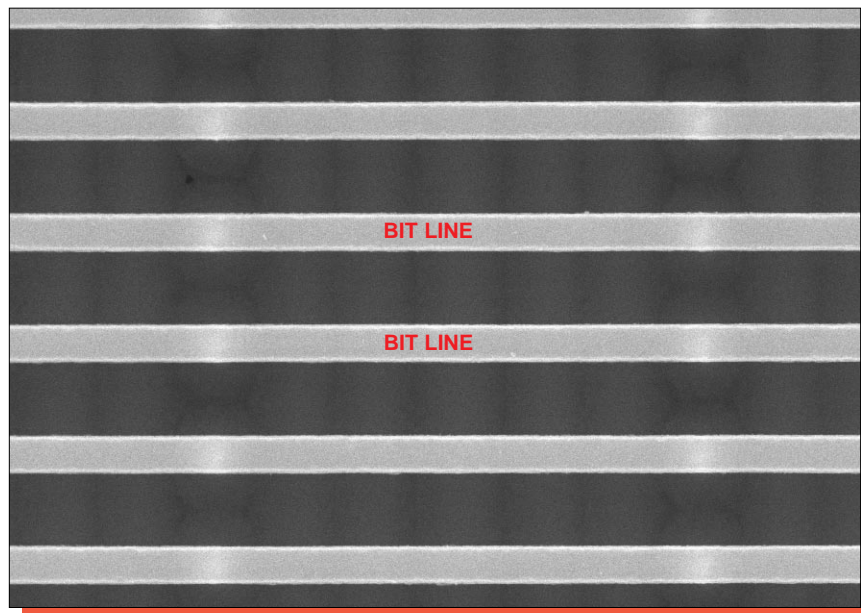
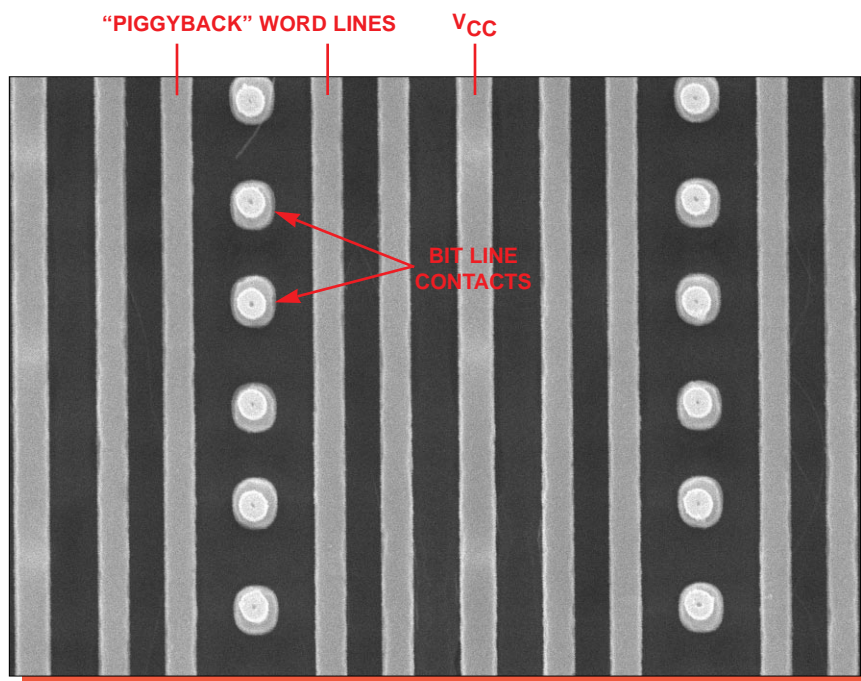
Figure 41. Topological SEM views of the Cache SRAM array. Mag. 6500x, 0°.

- Wells: Apparently twin-wells were used in a N-epi on a N substrate. Definition was normal.
- Buried contacts: Not used.
- SRAM: As mentioned, Level 1 on-chip data and code Cache memory cell arrays (16KB each) were employed on the device. The SRAM cell array used a 6T CMOS SRAM cell design. Metal 3 formed the bit lines (via metals 1 and 2). Metal 2 distributed Vcc and formed “piggyback” word lines. Metal 1 distributed GND and was used as cell interconnect. Polycide formed the word lines/select and storage gates. Cell pitch was 4.2 x 4.6 microns (19 μm^2).

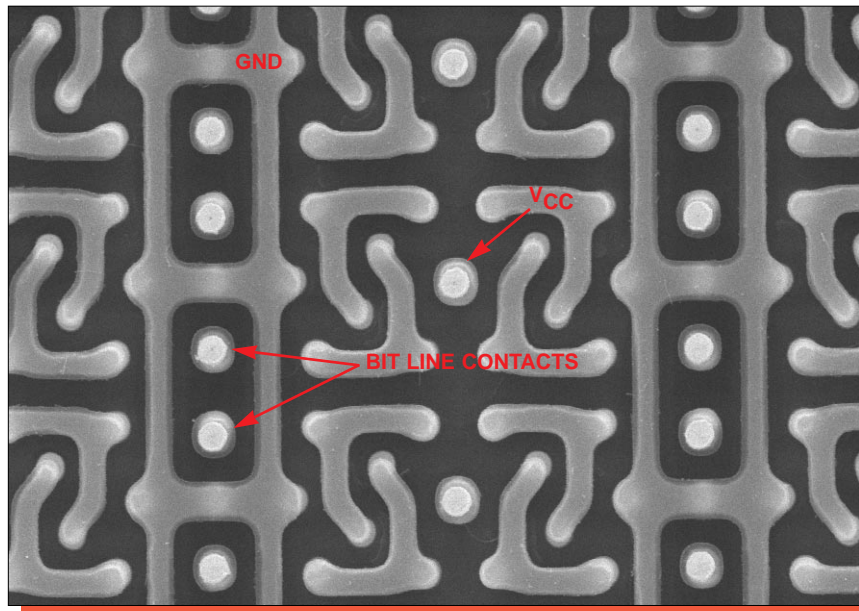
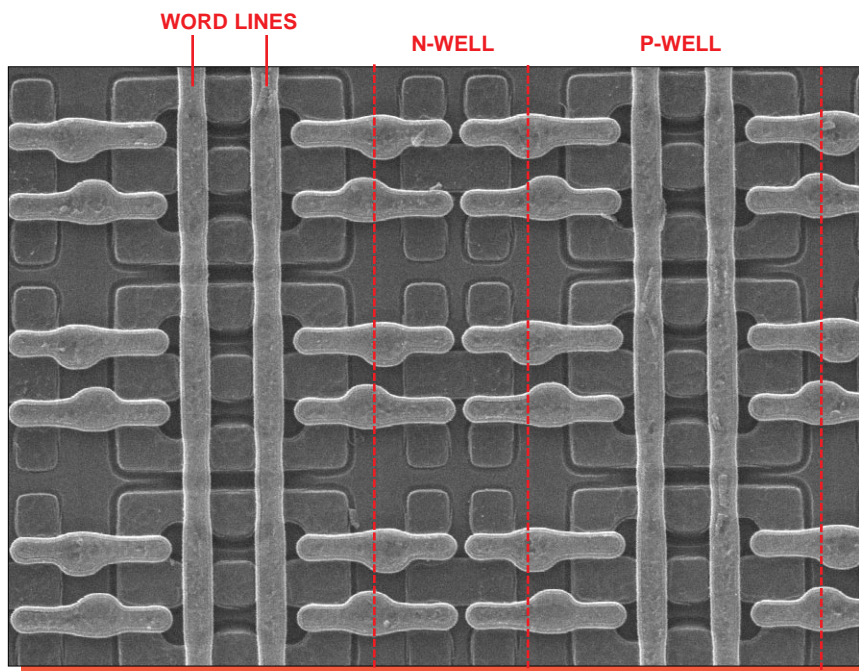
Figure 41a. Topological SEM views of the Cache SRAM array. Mag. 6500x, 0°.

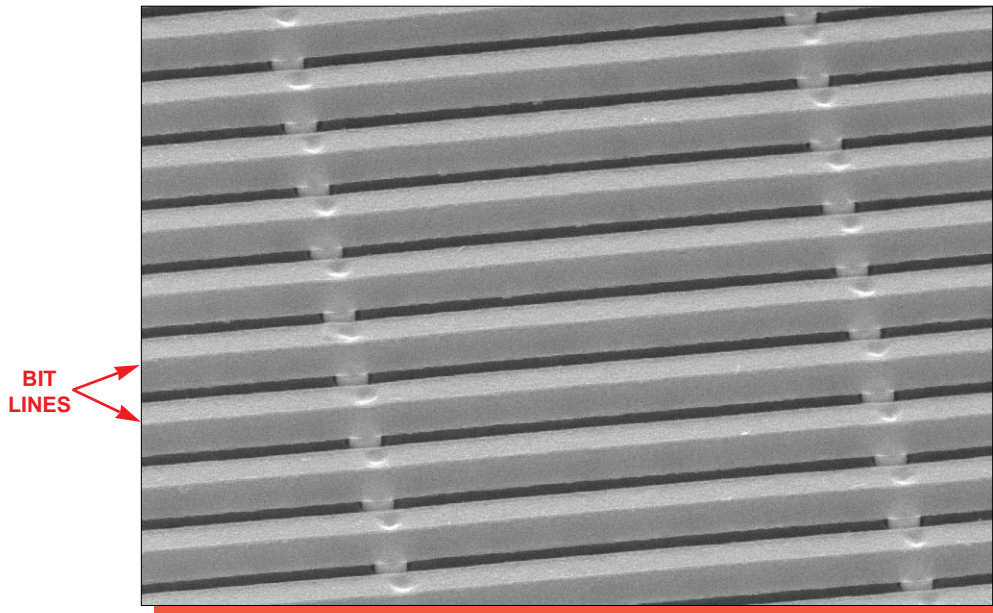
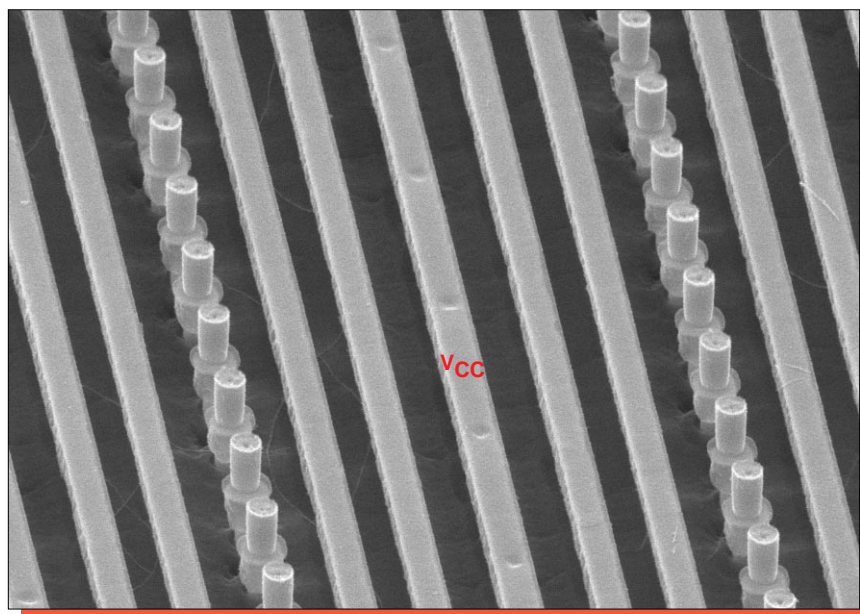
Figure 42. Perspective SEM views of the Cache SRAM array. Mag. 7000x, 55°.

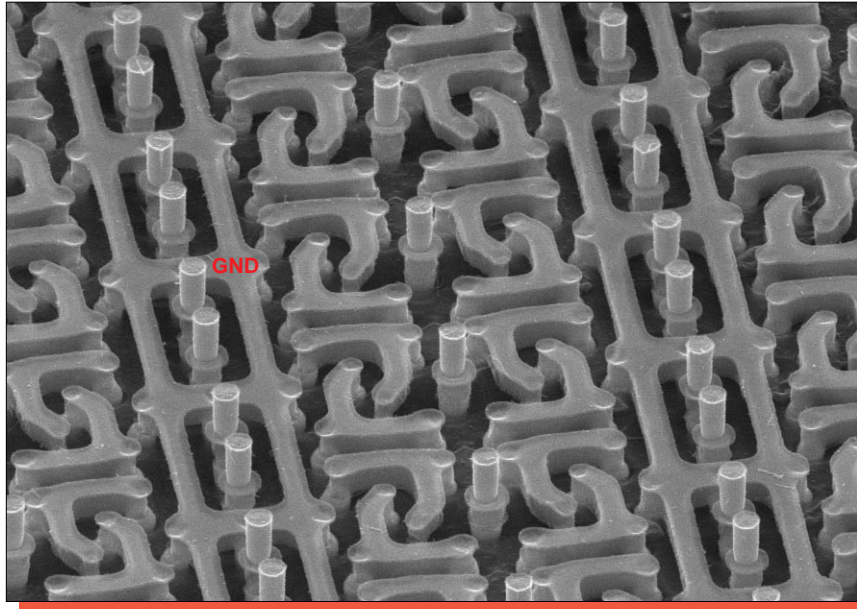
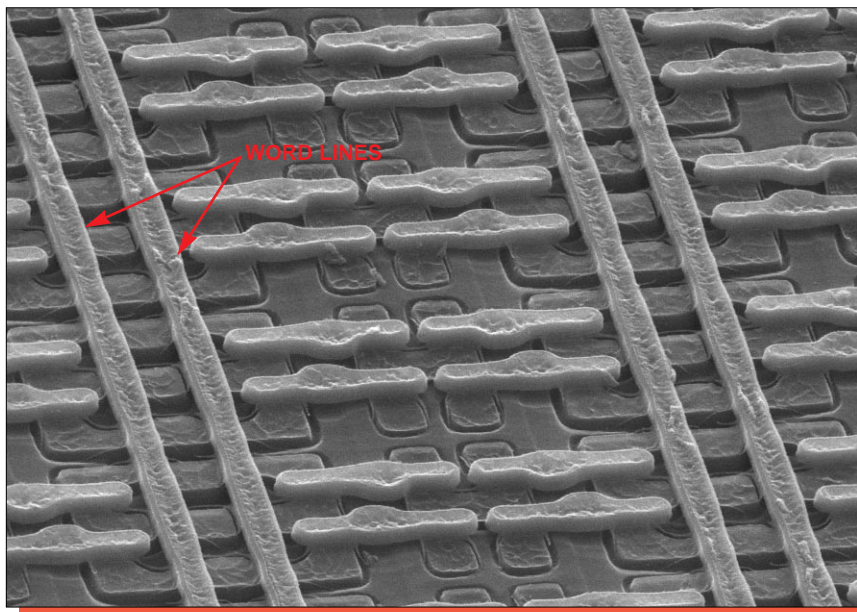
Figure 42a. Perspective SEM views of the Cache SRAM array. Mag. 7000x, 55°.

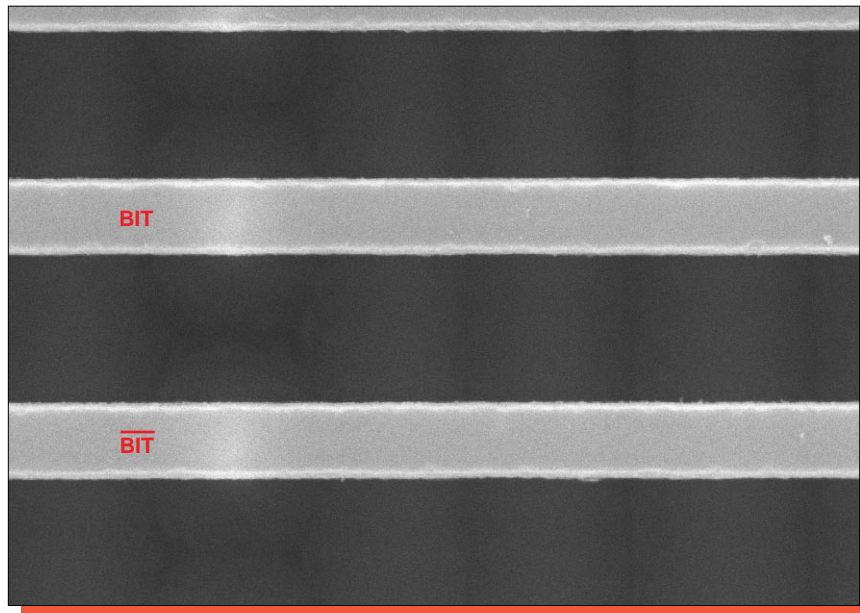
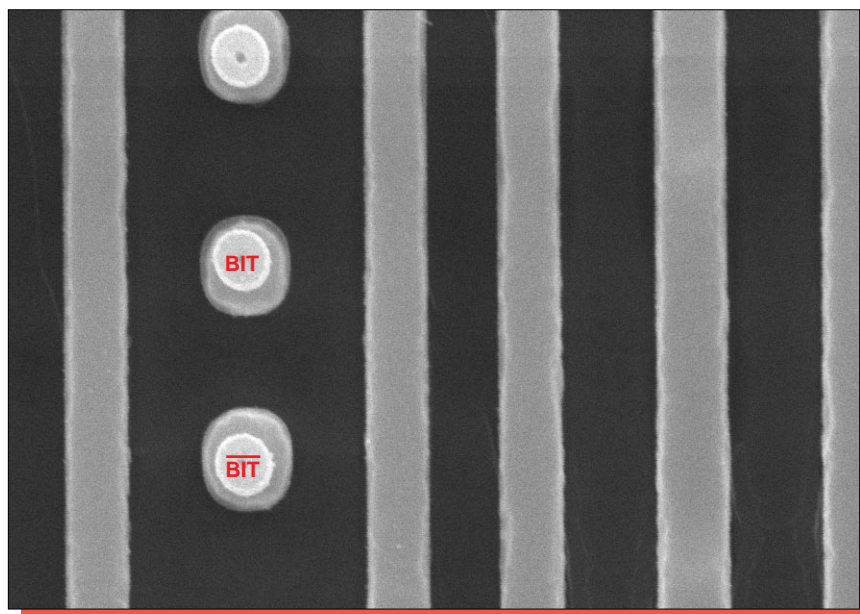
Figure 44. Topological SEM views of a Cache SRAM cell. Mag. 13,000x, 0°.

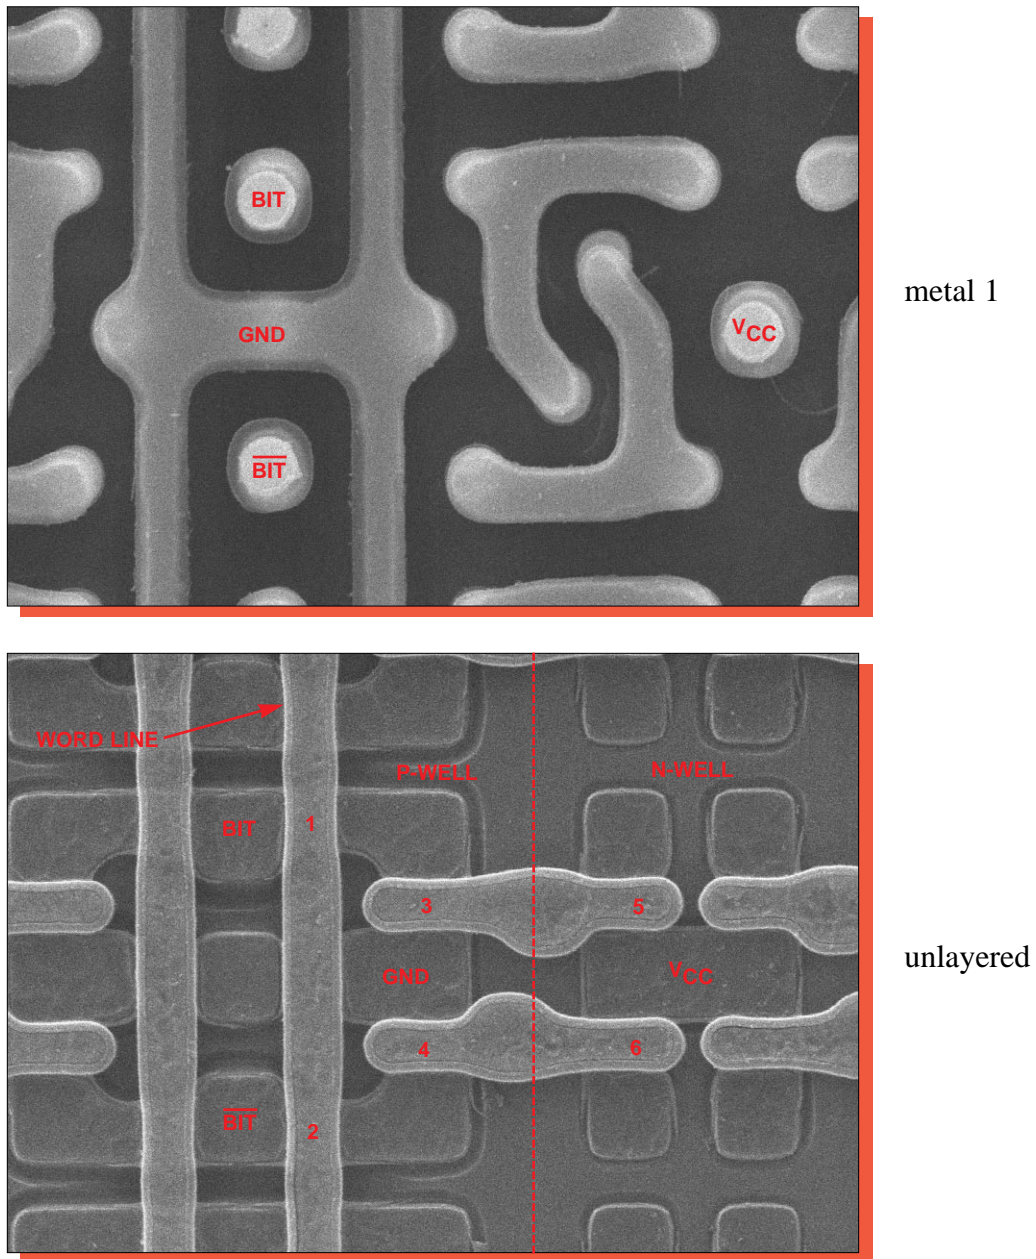
Figure 44a. Topological SEM views of a Cache SRAM cell with schematic.
Mag. 13,000x, 0°.

- Wells: Twin-wells in an N-epi on an N substrate.
- SRAM: Level 1 on-chip data and code cache memory cell arrays (16KB each) were employed. The memory cells used a 6T CMOS SRAM cell design. Metal 3 formed the bit lines (via metal 1 and 2). Metal 2 distributed Vcc and formed “piggyback” word lines. Metal 1 distributed GND and was used as cell interconnect. Polycide formed the select and storage gates. Cell pitch was 4.6 x 4.2 microns (19 μm^2).
