1. Report No. FHWA-RD-94-141		2. Government Accession No.		3. Recipient's Catalog No.	
4. Title and Subtitle TravTek SYSTEM ARCHITECTURE EVALUATION				5. Report Date

15. Supplementary Notes Contracting Officer's Technical Representative (COTR) - Frank Mammano, HSR-12					
16. Abstract The TravTek System Architecture Evaluation documents in detail the TravTek system, including the Traffic Information Network (TIN), TravTek Information Services Center (TISC), Traffic Management Center (TMC), and the TravTek vehicle. The TravTek system achieved a high state of automation. Link travel time data were received automatically from the probe vehicles, freeway management system, and arterial control management system. These data were fused and distributed to the vehicles, all without operator intervention. The process for estimating link travel times worked well on the basis of information available. TravTek needed more high quality traffic information to provide vehicle routing that had the benefit of accurate, up to minute traffic information. Probe vehicles provided reliable travel times, but reported significant travel time variations on arterial links due to stop time at intersections.

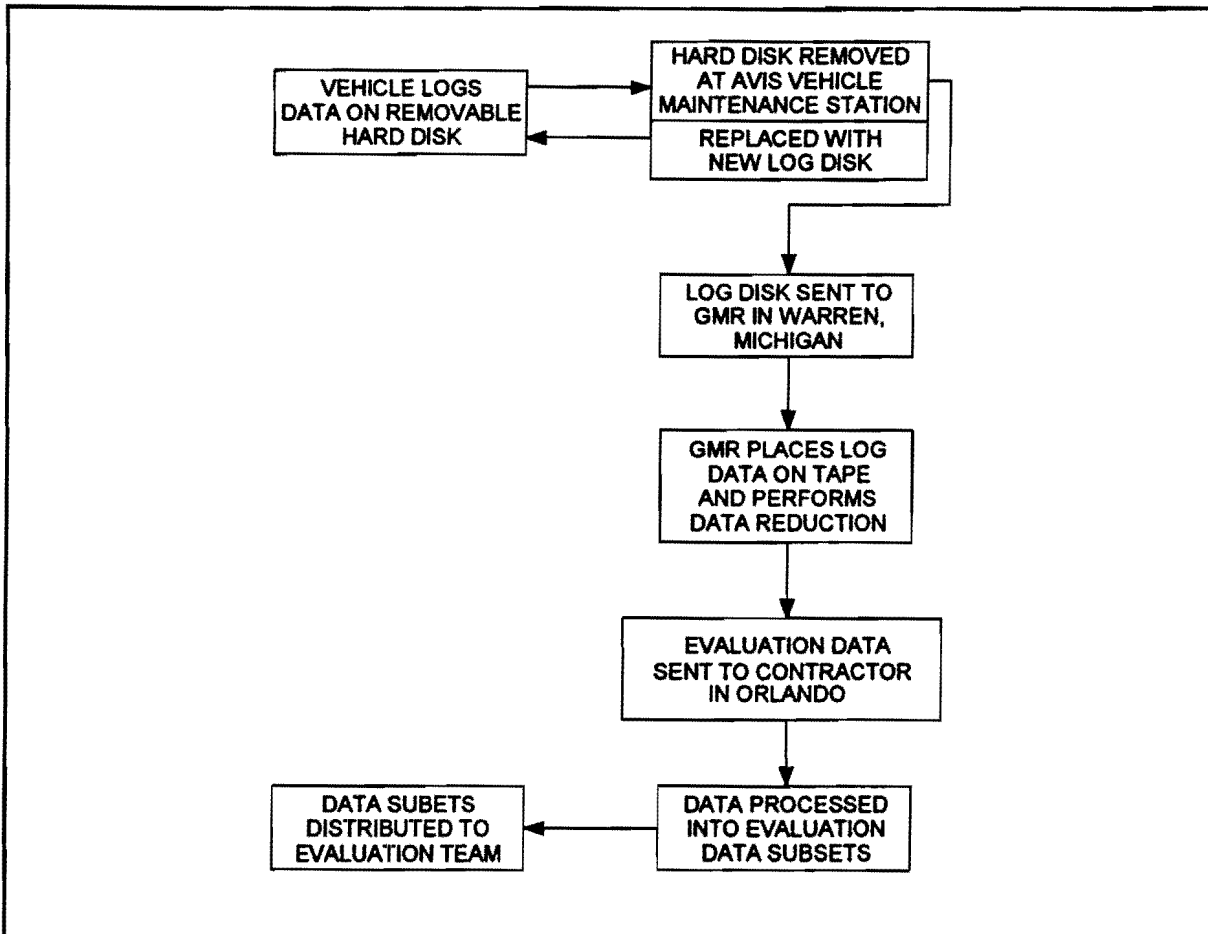
**Figure 19. Vehicle log data distribution path.**
