TravTek System Architecture Evaluation

Publication No. FHWA-RD-94-141

July 1995

U.S. Department of Transportation
Federal Highway Administration

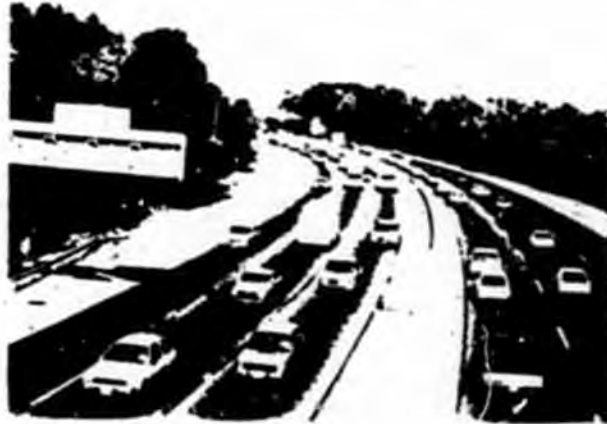
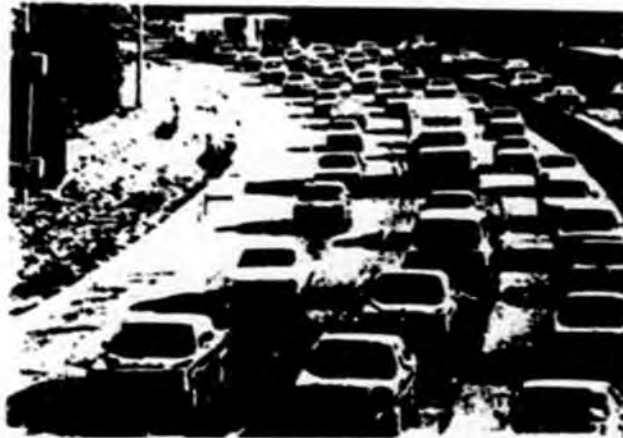
Figure 8. Illustration of moderate and heavy congestion levels.⁽¹⁵⁾

In addition to incident information, TIN Users also provided information about the location, magnitude, and expected duration of traffic congestion. Traffic congestion was entered in the system as either **HEAVY** or **MODERATE**. Examples of heavy and moderate traffic congestion levels are shown in figure 8.

MODERATE CONGESTION

HEAVY CONGESTION

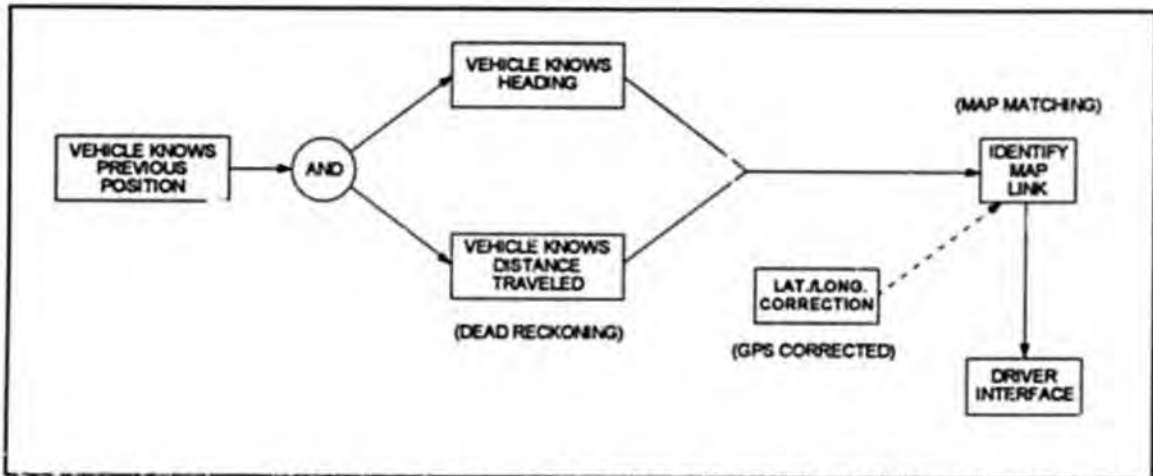
Figure 30. Vehicle positioning function.

that the navigation process accurately determine the exact position of the vehicle on the street network. This made the navigation function one of the most critical of all of the vehicle functions. If the vehicle's position could not be accurately determined, many of the other systems would provide the driver with erroneous information, which not only degraded the driver's impression of the utility of the system, but also increased travel time and navigational waste by TravTek vehicles. A diagram of the Navigation Function is shown in figure 30.
